7G-DCT (724.0) Care & Maintenance

It's strong, but needs some care to stay that way.

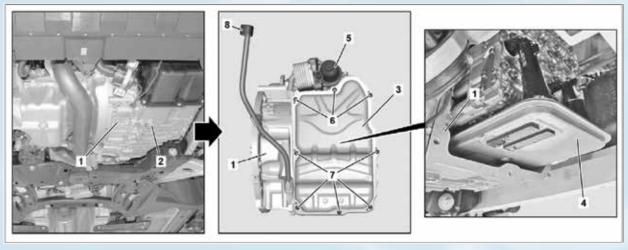
The oil pan (3) on the 7G-DCT transmission is vertical, at the front of the transmission unit (1). The pan screws (6, 7) are tightened to a torque of 8 N-m, while the oil drain plug (2) has a torque spec of 30 N-m. Note the two tubes on the lower oil filter (4), and the cover for the second oil filter (5).

After cleaning off the drain plug, check it for damage and (assuming it's OK) reinstall it with a new seal ring. The work instruction states the tightening torque is 30 N-m, but you're always well-advised to recheck the specs yourself.

Insert the new oil filter carefully, as it has two fittings that plug into the transmission housing. Reinstall the oil pan (a new gasket is mandatory) starting with the bottom five screws. As with transmission pan bolts since forever, with their 'lighter-than-finger-tight' torque spec, these are no different: If you don't want the oil pan leaking, tighten to just 8 N-m and no more. Reinstall the under

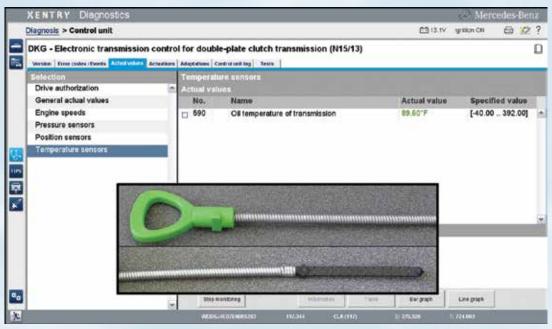
The Mercedes-Benz transmission dipstick tool. The calibrations on the tip are different from the tool used for transmission 722.6, for example. Always use the correct tool to measure fluid level, and carefully follow the temperature requirements as displayed by XENTRY when measuring the fluid level.

Once the oil hits 40° C, you have about two minutes to take your measurements. Using the special tool dipstick W168 589 01 21 00, check the oil level carefully at least

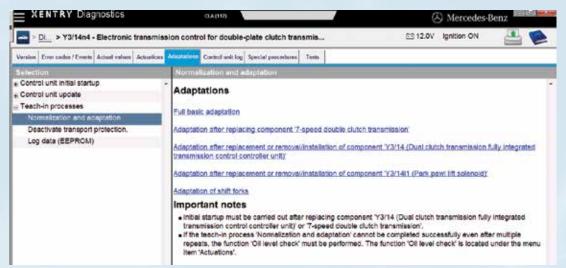
On the Adaptations screen, select Teach-in processes. A Shift Forks adaptation can help with shift quality complaints. A Full Adaptation is only for when the entire transmission has been replaced.

If there's a shift-quality complaint, use XENTRY to perform a Shift Fork Adaptation. The transmission oil temperature needs to be raised to 35°C/95° F or higher, and you have to apply the service brake throughout the entire procedure. Once started, it runs automatically and takes only a few minutes to complete. It's not

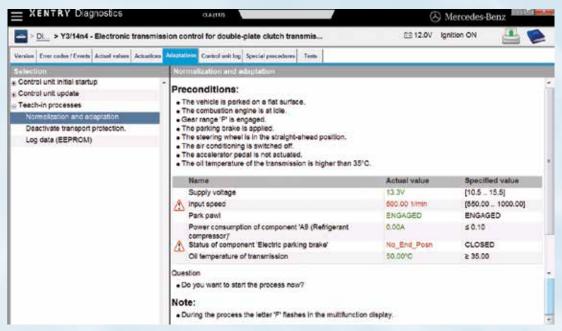
There are several preconditions to be met before a Shift Forks adaptation can be started, but it then runs automatically and takes about 10 minutes.

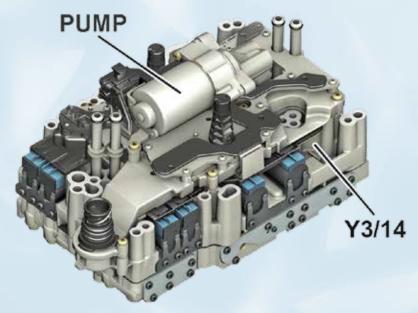
The transmission control unit (Y3/14) features an auxiliary oil pump to deliver oil pressure during Automatic Engine Stop periods, as well as during times of high oil demand. It can be replaced separately.

transmission has overheated. If gentle driving, allowing the trans to cool down, doesn't restore normal operation, suspect the electric auxiliary oil pump.

be missing from the vehicle data card in the Electronic Parts Catalog. This will lead to identifying the wrong part number for the controller unit Y3/14, the control unit Y3/14n4, or the complete transmission. To be certain of ordering the correct part, read out the "MB Hardware Object Number" of the control unit Y3/14n4 using XENTRY (this is shown on the Quick test), and reference the information in the SI to determine the correct spare part numbers. Also, in the supremely rare case where you are replacing either of these parts, you really need to read the work instructions to avoid damaging the parts.
