AN INSIDE LOOK AT PORSCHE TRANSMISSIONS

By: Tim Pott

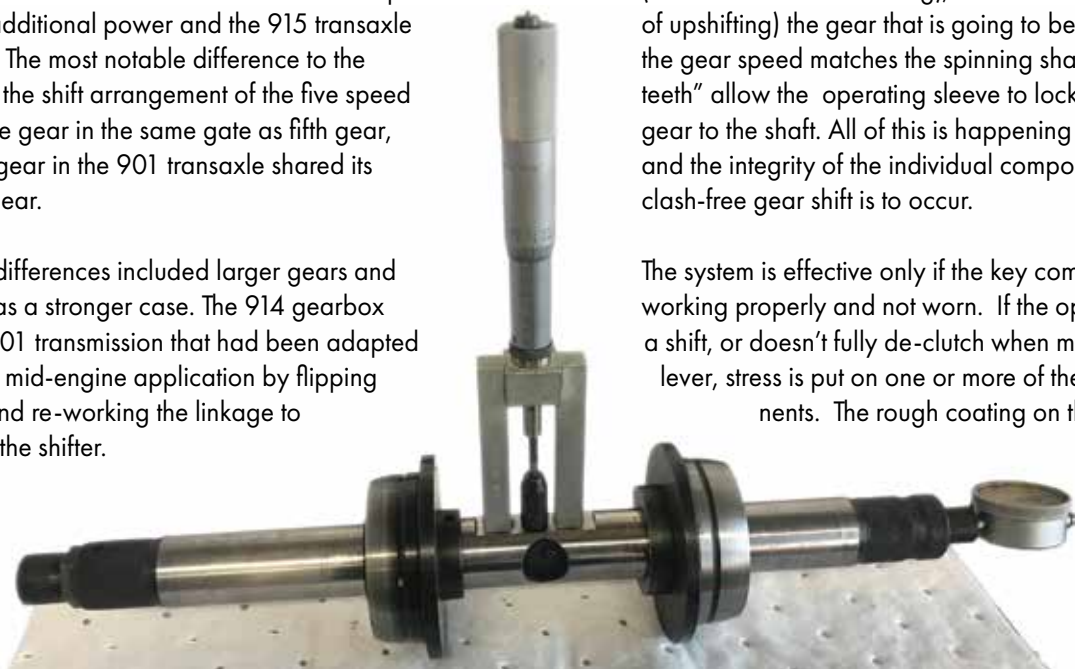
This is the setup tool for pinion gear depth being calibrated for its specific application.

While there is nothing new about what is measured in a Porsche ring and pinion gear setup, how they are measured is quite unique. Specifically pinion gear depth, one of the most critical dimensions to achieve, requires highly specialized tooling, and there is no way to make the proper adjustments without them.

The method for setting pinion depth is accomplished by putting shims behind the pinion shaft bearing, and this can be measured only with the factory designed equipment. This cannot be "fudged" or estimated or even set up with the original shim selection in the hope that it will work. The tapered roller bearings on each side of the differential housing can often be replaced without upsetting the ring gear adjustment, but checking the differential pre-load, ring gear backlash and gear patterns are all standard operating procedures after replacement and can be accomplished using more generic or even locally fabricated equipment.

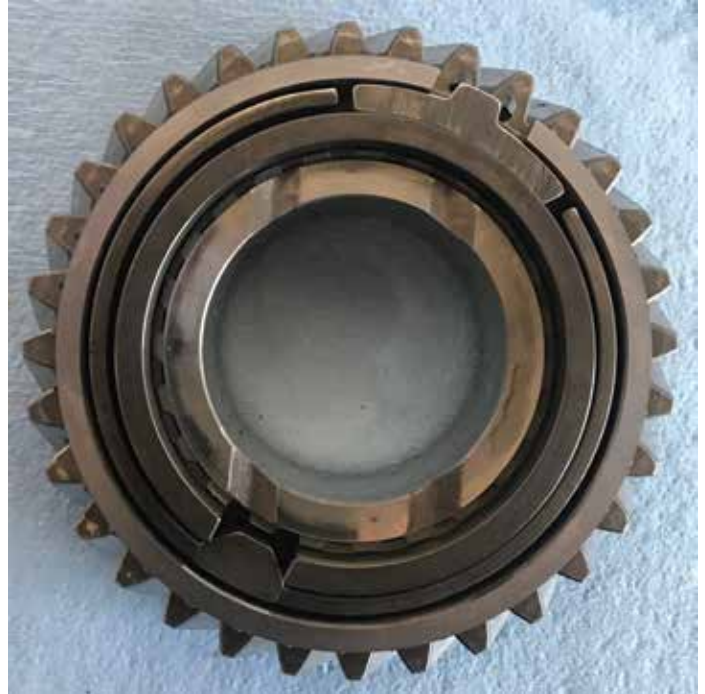
The main components of the Porsche style synchronizer are shown here prior to snap ring installation.

The Porsche/Schmidt style of synchronizer incorporates five main components; a brake band, an anchor, a stop, a friction ring and "dog teeth."

An operating sleeve, which is fixed to its respective shaft, first contacts the friction ring which has a surface that has a rough spatter coating. As the operating sleeve grabs the synchronizer, it turns until it hits the stop. The stop, in turn, then energizes the brake band, which then applies more tension on the synchronizer ring. This action is all to either speed up, (in the case of downshifting), or slow down, (in the case of upshifting) the gear that is going to be engaged. As the gear speed matches the spinning shaft, pointed "dog teeth" allow the operating sleeve to lock the selected gear to the shaft. All of this is happening in split seconds and the integrity of the individual components is key if a clash-free gear shift is to occur.

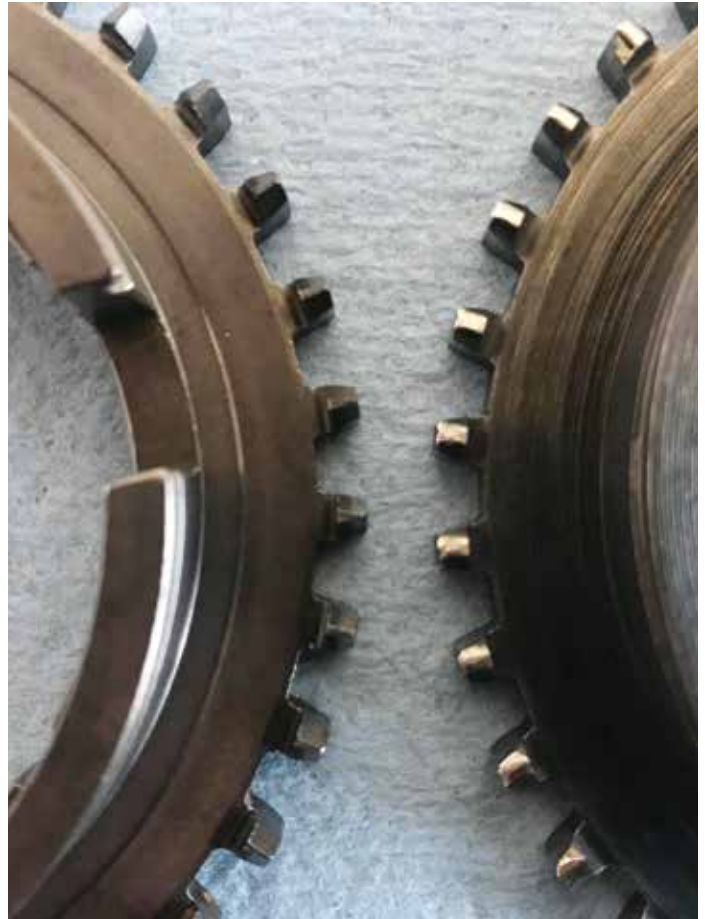
The dog teeth on the right are severely worn. Compare them to the new unit on the left.

The effect of improper use, or a missed shift, will begin a “snowballing” effect as wear on one component compromises others. This is why it is key during an overhaul to carefully assess each component for wear or damage due to past use. If the transmission is relatively high in miles, all synchronizer rings should be replaced as a matter of course, as these are the front line of the entire shifting process. Always pay close attention to the dog teeth as well as the teeth on the operating sleeve.

Slight wear or evidence of minor contact to the teeth are okay, but the points of the engagement dog teeth should be distinct and relatively sound. The operational caution here is: if in doubt, replace it.

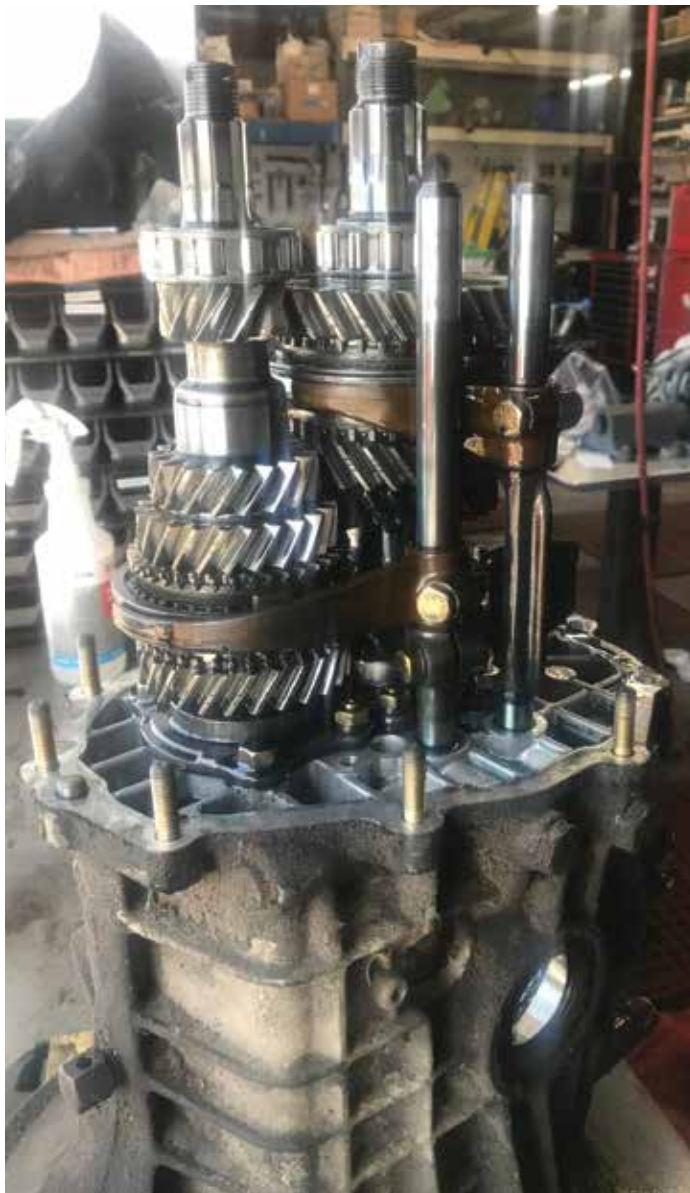
Note the pinch bolt that clamps the brass fork to the shaft. This is where the fine tuning of the adjustment is made.

The procedures for this must be followed very carefully as per the factory repair manuals. The shift rails and linkages are adjustable on two planes; fore and aft, as well as their relationship to one another, side to side. Failure to get this part of the repair done properly might necessitate a complete disassembly to access the pinch bolts on the shift rails that facilitate the adjustments. It is a great idea to engage gears while they are exposed prior to installing the housing and observe the movement of the shift rails to assure that they are properly adjusted.

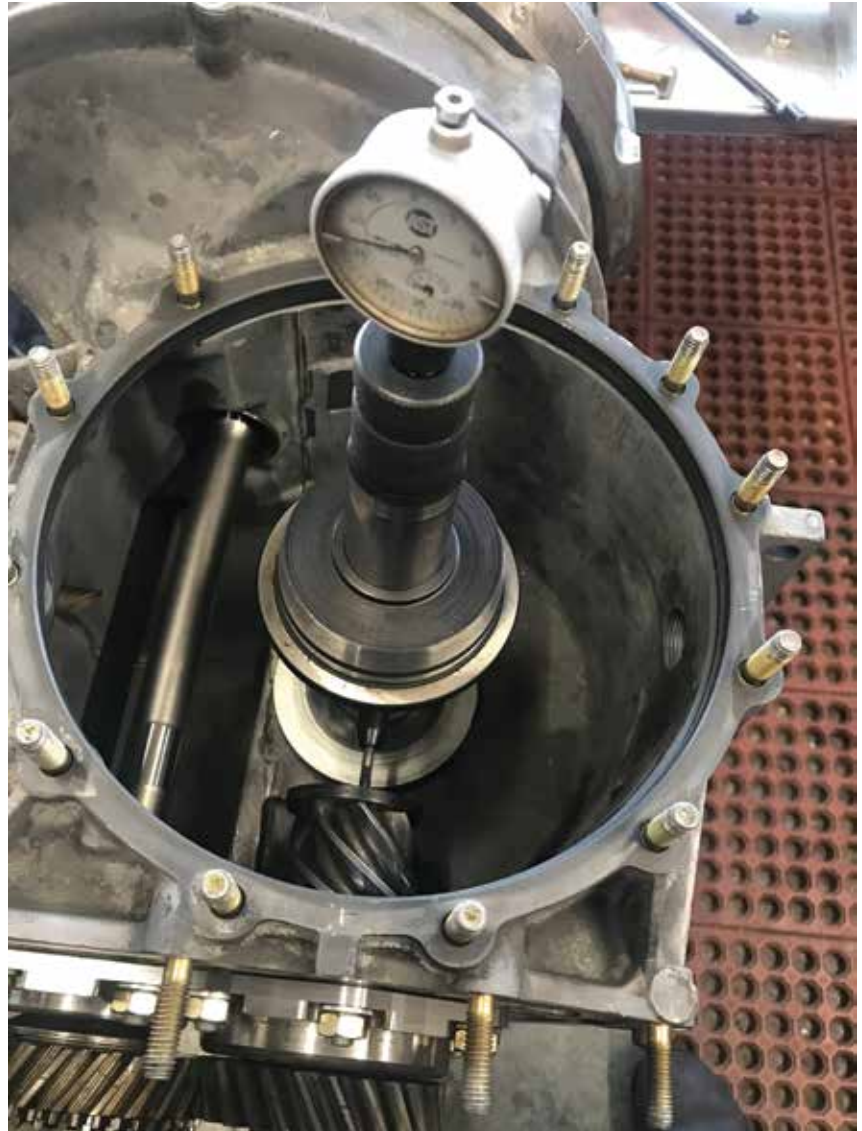
This is the tooling measuring pinion depth. The differential side cover is off for a better view.
