Goodbye Cable! Volkswagen's Throttle-by-Wire

This state-of-the-art system has been around for a while. You should know how it works. Today's technician also needs to know how this system integrates into the big picture of engine management. Let's also look in to the need for proper connections in this system.

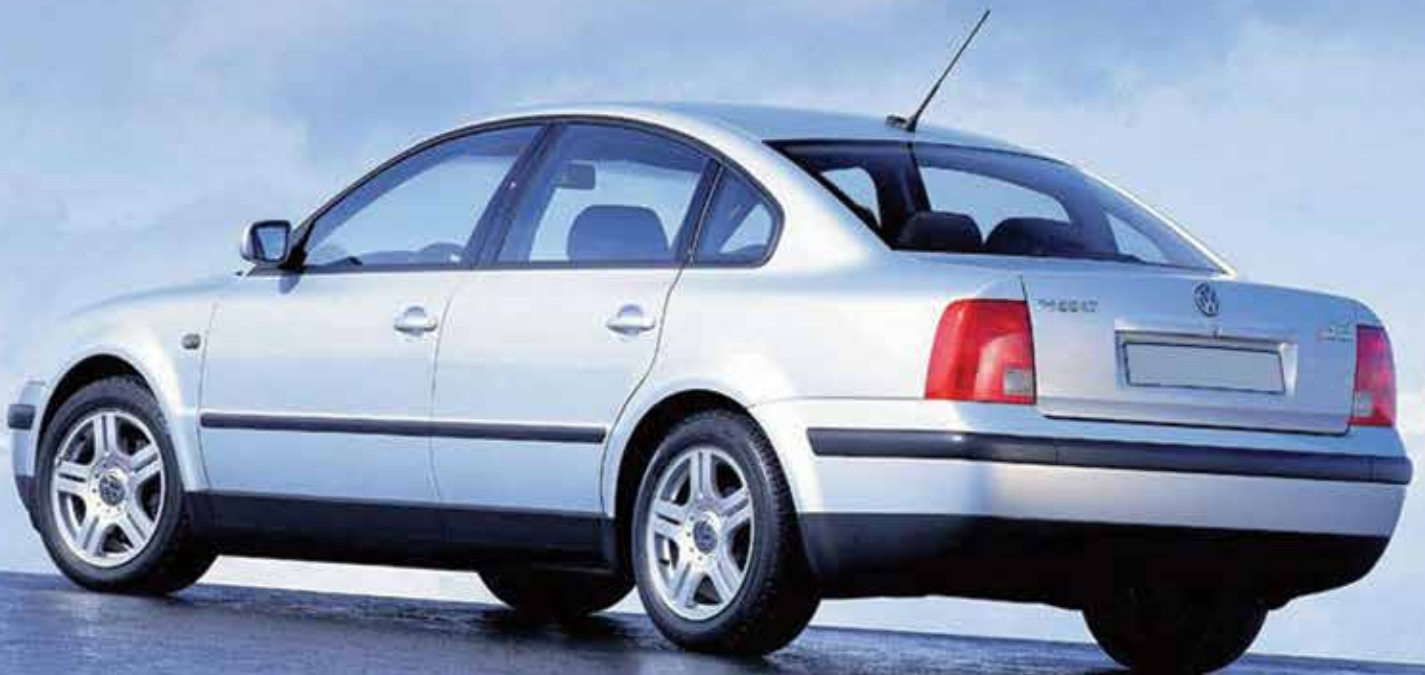
Throttle-by-wire made its first appearance in Volkswagen vehicles in 1999 with the adoption of Robert Bosch Motronic ME 7 engine management for the 2.8L VR-6 engine, as found in this Passat.

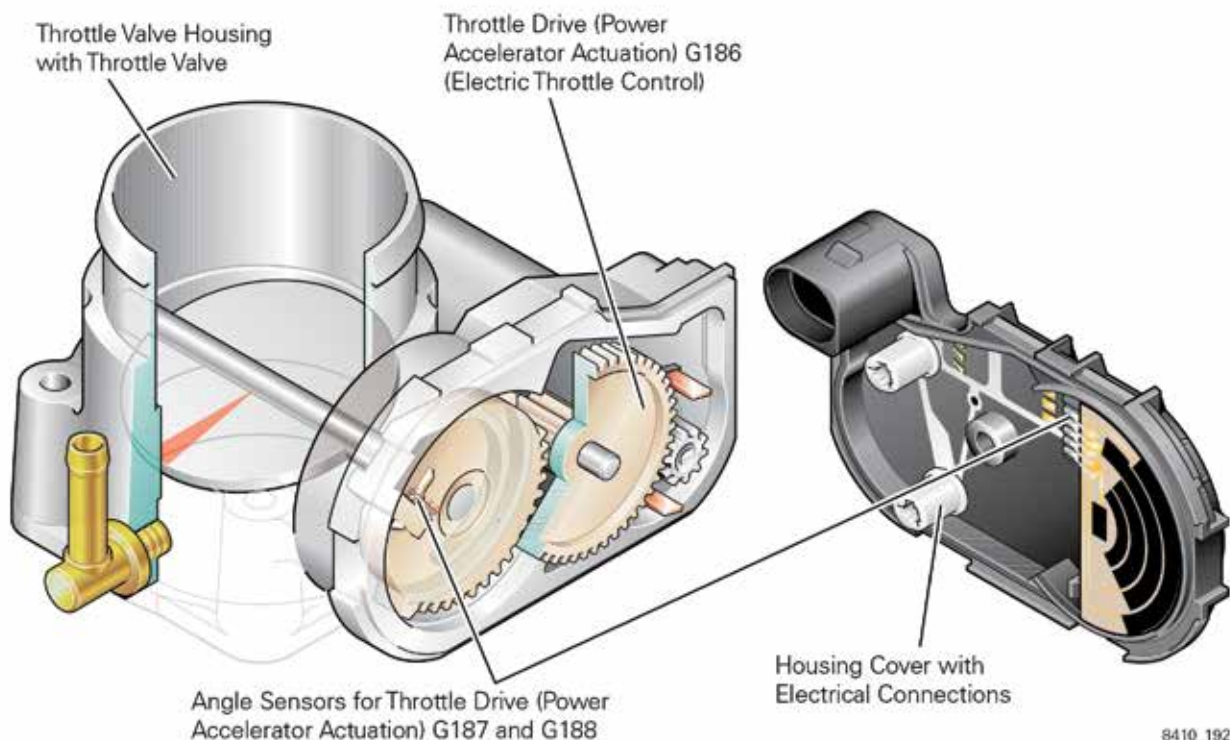
The electronic throttle valve assembly isn't actually that complex. Essentially, an electric motor rotates the throttle valve shaft through a set of reduction gears according to computer commands.

Basically, an electric motor rotates the throttle valve shaft through a set of reduction gears according to computer commands. Benefits over a simple cable? More than you might think. Not only does it maximize engine torque and efficiency by keeping the velocity of the intake stream and manifold vacuum at higher levels than a human could ever do, it also allows cruise control without the necessity of adding a big vacuum actuator and attendant hardware.

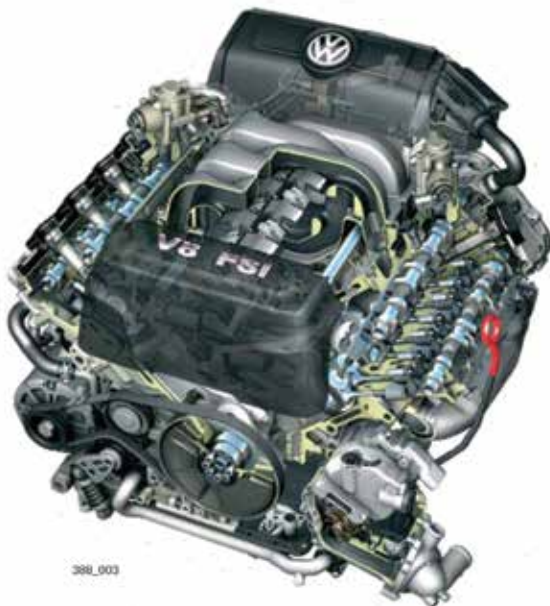
Even the latest models such as this Tuareg II 4.2L V8 with MED 9.1.1 engine management use essentially the same electronic throttle system, just with a bigger bore than you're probably used to seeing on Volkswagen engines.

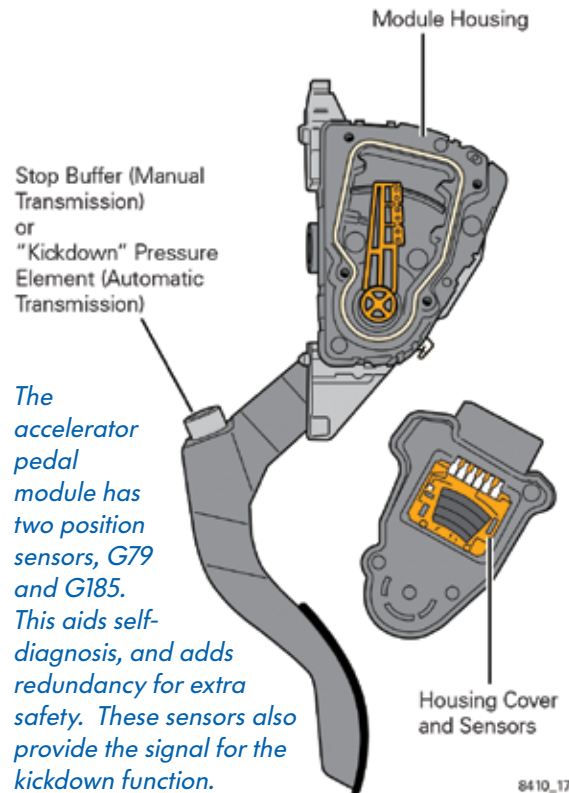
8410_174

The accelerator pedal module combines the accelerator pedal and the accelerator position sensors into one assembly. The electronic components of the pedal module are:

- Throttle Position (TP) Sensor (G79)
- TP Sensor (G185)

The redundant throttle position sensors are linear to each other on different scales. Like the dual throttle drive sensors, the duplicate sensors are for self-diagnosis. They also provide an analog signal to the ECM referencing accelerator position, and the kickdown function is incorporated into the module. If the driver activates the kickdown, the full-throttle voltage of the accelerator pedal position senders is exceeded. The ECM interprets this as a kickdown and sends a signal the Transmission Control Module (TCM) by way of the CAN data bus.

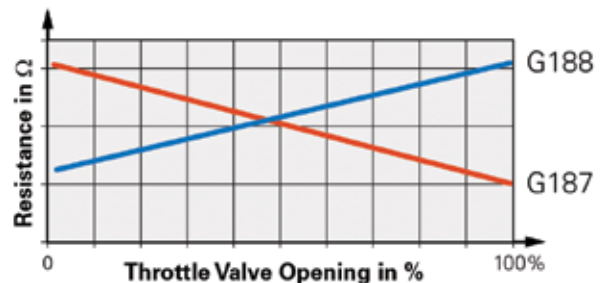
8410_176

One of the intelligent safety measures in the design is that the two angle sensors in the throttle body assembly are opposite in resistance, allowing for continuous cross-checking by the ECM. In later models, throttle-by-wire is integrated into the K132 Electronic Power Control (EPC) system.

One of the clever features of the design is that the two Throttle Drive Angle Sensors (G187 and G188) are opposite in resistance, and are used for continuous cross-checking by the ECM. The sensors are provided with a 5V reference voltage, then the ECM reads the voltage drop across these variable resistors and uses this to monitor throttle valve angle. The assembly including the throttle drive mechanism is designated G186. In later models, throttle-by-wire is integrated into the K132 Electronic Power Control (EPC) system.

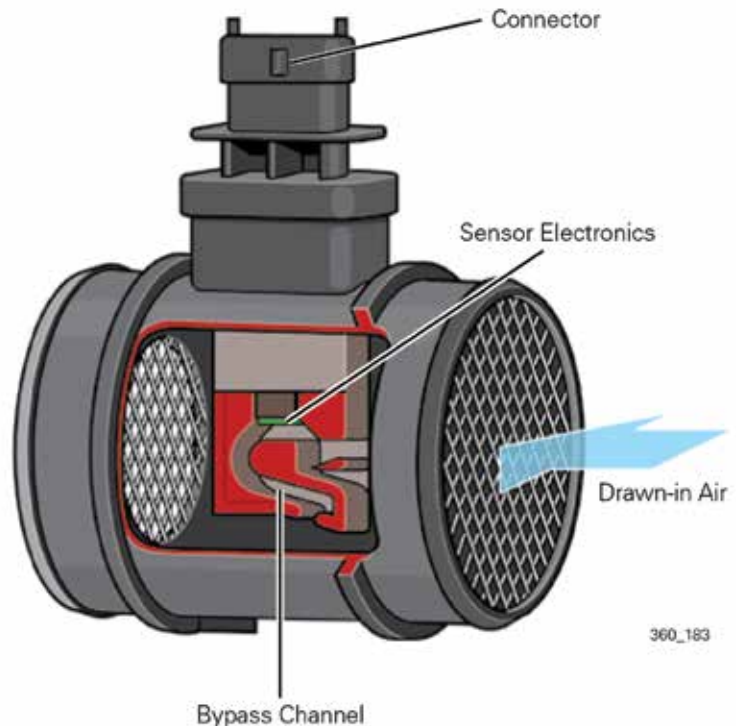
Related components, such as the MAF, can also turn on the EPC warning light.

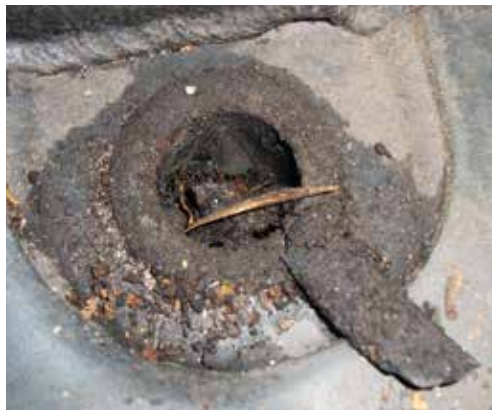
Something as simple and easily-avoidable as a clogged cowl drain can cause infiltration of water into the wiring and electronic components.

But what's causing it to happen? Most of you will immediately break out your scan tool (VAG or otherwise), pull codes, and pore over the data stream. That seems sensible, but our investigations point to the need to check some basics first, mostly wiring and connections for water infiltration (see if the sunroof

and cowl drains are clear), corrosion, or loose pins in the connectors. Junction boxes, especially near the battery, and various branch connections are especially vulnerable.

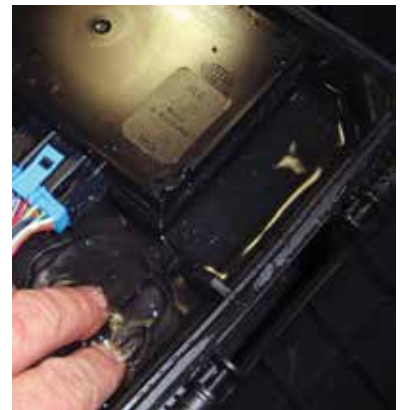
Look at all that H₂O! Better start looking for this kind of trouble before you start replacing parts.
