Facelift

Restoring the Beauty of Mercedes-Benz Carbon Fiber Components

Carbon fiber reinforced plastic (CFRP) is showing up on more Mercedes-Benz models as the company reduces weight. We provide a few tips on what to look out for when repairing CFRP components.

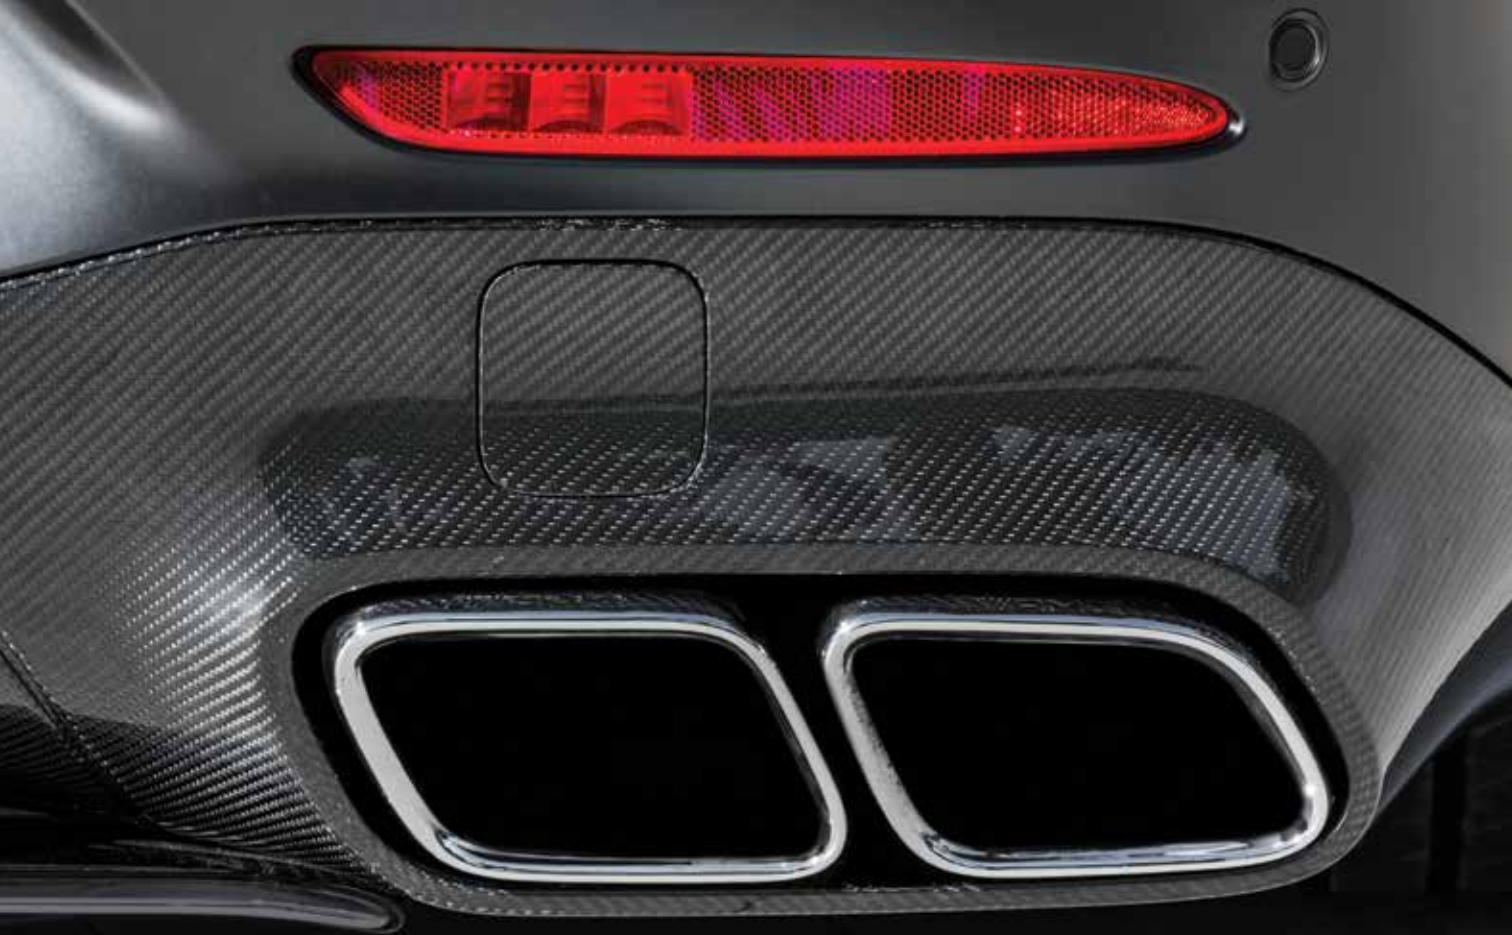
The carbon fiber rear diffuser on this 2019 AMG GT 4-door Coupe may be repairable, but only if damage is either limited to minor surface scratches, or is hidden out of view on the bottom area of the part.

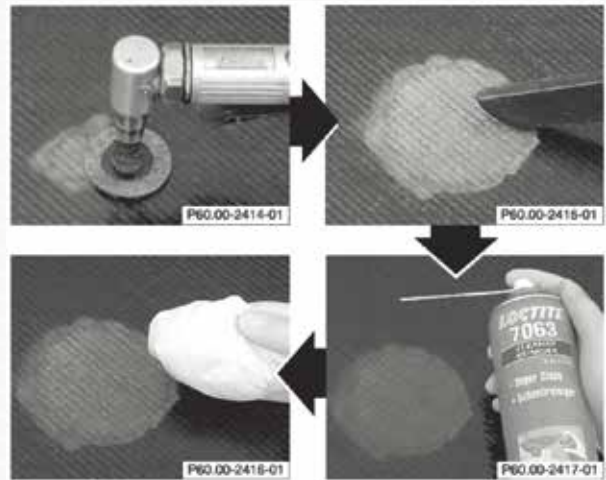
Two things are key when repairing minor surface damage to carbon fiber components. First, do only light sanding, and use sanding disks specified by Mercedes-Benz, to reduce the risk of grinding too deep into the fiber composite layers. Second, clean, clean, clean. Use a wet/dry vacuum to remove sanding dust, then clean the fiber composite surface at least three times with application of fresh degreasing agent each time. Never blow shop air over the surface, as even a tiny amount of oil from your air supply can prevent the epoxy resin from curing properly.

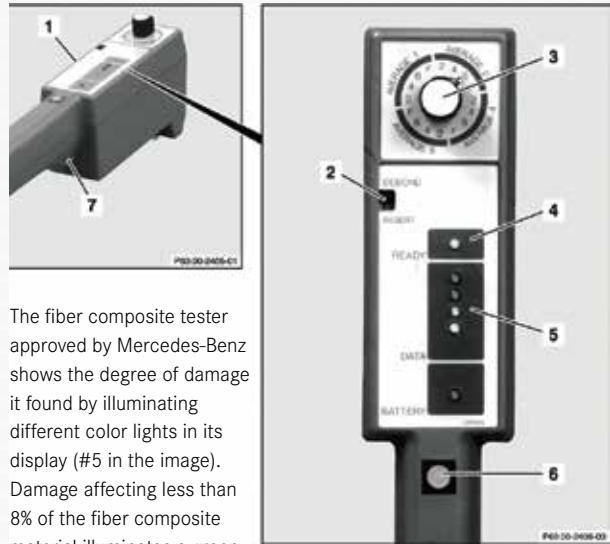
The fiber composite tester approved by Mercedes-Benz shows the degree of damage it found by illuminating different color lights in its display (#5 in the image). Damage affecting less than 8% of the fiber composite material illuminates a green light, and 8% - 16% sets a yellow. The next three levels indicate damage found on up to 40%, 80%, and greater than 80% of the composite material. These result in increasing intensities of red lights, signaling the difference between damage that may be repaired with minimal or moderate amounts of effort, and that which can more efficiently be addressed by replacing the entire component.

A Mercedes-Benz -approved Fiber Composite Tester uses special sensor technology to “see” breaks and other anomalies in subsurface carbon fibers and the resin base in which they are embedded. However, no non-destructive test is guaranteed to detect 100% of damage, especially any that is below the surface. If for any reason you suspect there is subsurface damage to a structural component, even if testing does not confirm it, that part must be replaced.

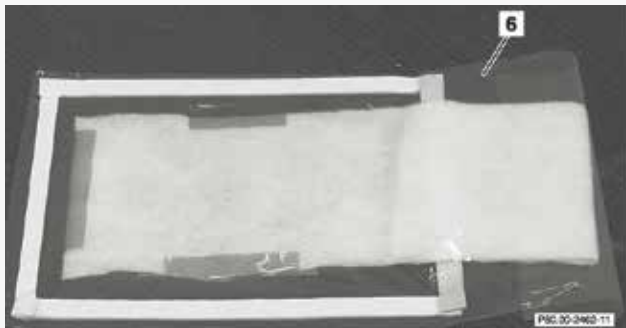
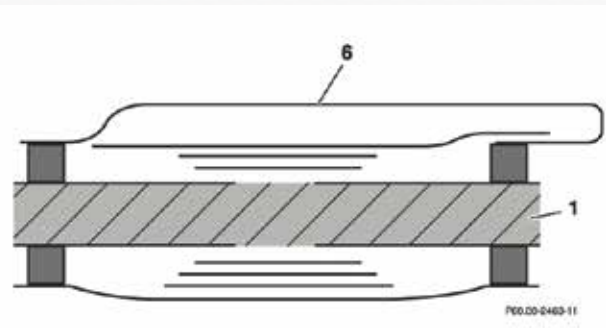
The “dry layup” CFRP repair method uses carbon fiber patches that are pre-impregnated with epoxy resin to repair the damaged area. Vacuum is applied to help infuse the resin through the patch. Layers of perforated film are placed on the top and bottom of the composite material to allow excess resin to be drawn away from the panel (#1 in this image) for disposal after curing. Plastic is taped around the damaged area (#6 in this image) to seal it for application of vacuum. To prevent the plastic from sticking to the patch and causing an uneven distribution of the epoxy resin as the vacuum draws it out, there is a vacuum mat (the white material in this image) that functions as a spacer between the plastic and the patch. A valve is punched through a hole in the plastic, to allow vacuum to be drawn.

To repair a damaged CFRP part, you grind out the damaged area (or areas), and add to each damage area a new carbon fiber patch that has been pre-impregnated with an epoxy resin. The “pre-preg” mat is placed in the

cutout area, excess resin is forced out via vacuum, and the piece is cured over a specified number of hours. Done this way, the process is called a “dry layup.”
