# Pre- and Post-Repair Scanning for Restoration to Pre-accident Condition

Use pre- and post-repair scanning to learn which Advanced Driver Assist Systems (ADAS) are on the vehicle, what fault codes have been stored, and how to avoid a few diagnostic rabbit holes.

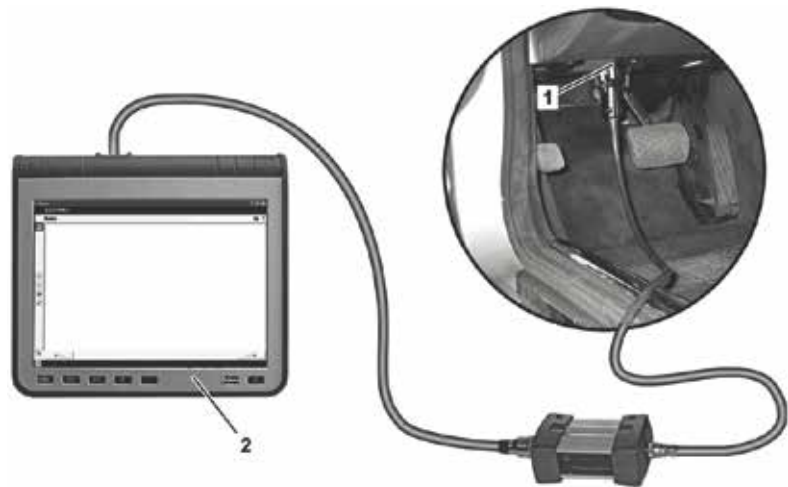
The Mercedes-Benz STAR DIAGNOSIS system allows you to readout factory fault codes that aftermarket scan tools may not be able to access.

Of course, a factory scan tool covers far more fault codes than even a high-level aftermarket scanner. Many codes related to ADAS components are OEM-specific and can only be interpreted by a STAR DIAGNOSIS or other Mercedes-Benz diagnostic service tool.

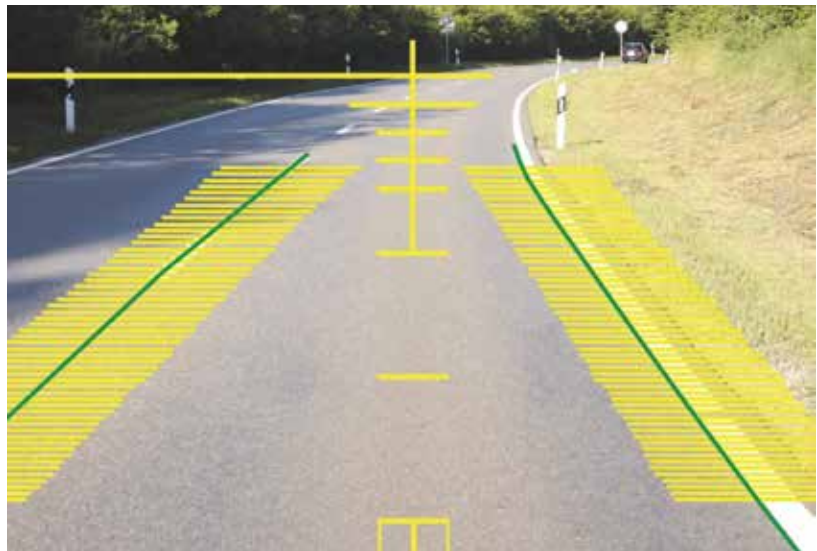
The Mercedes-Benz Lane Keeping Assist (LKA) system uses real-time video images of lane markings to calculate the relative position of the vehicle in the road. The green line in the center of the yellow overlay on each side indicates the borders that the LKA prevents the vehicle from crossing.

Mercedes-Benz Lane Keeping Assist (LKA) systems use real-time video images of where the vehicle is relative to lane markings in the road. When the Active LKA camera sees the vehicle traveling over the lane markings in the road, and warnings being ignored by the driver, the control module sends an actuation signal to another system to nudge the vehicle back on track.

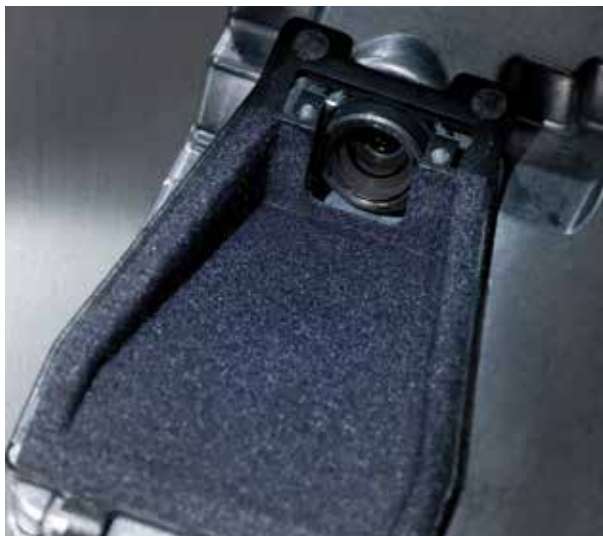
The multifunction camera used by the LKA system is mounted at the top center of the windshield on many Mercedes-Benz vehicles. If the front windshield is removed and replaced, the camera must be calibrated after installation. Calibration ensures that the camera position is properly accounted for so the system knows exactly where the lens is pointed relative to the vehicle.

replaced or disconnected from power for any reason must be calibrated to ensure that they point in the correct direction. Calibration and re-initialization verifies that the control module can communicate with the camera, and knows its orientation.

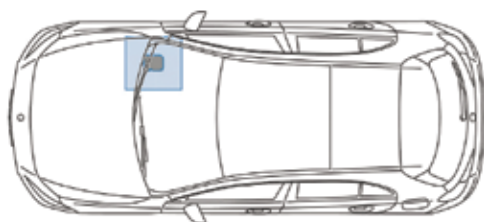
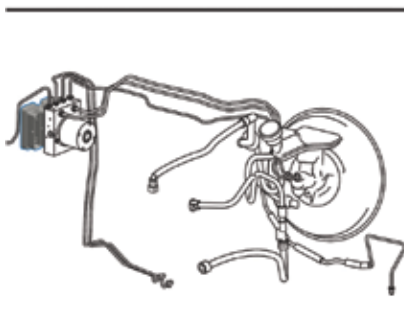
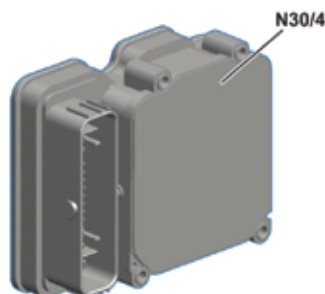
The ESP control unit (shown here on the 2018 and newer A-Class) processes inputs from rpm sensors at each axle, the accelerator pedal sensor, brake vacuum sensor, stop lamp switch, and other sources. It outputs commands to the drivetrain control unit, supplemental restraint system (SRS) control unit, brake pedal signal, and other devices. CAN bus technology networks all components to enable sensors to monitor hardware function, software to compare performance against specifications, and control modules to issue commands to actuate components or store fault codes as needed. This high-level of network connectivity generates a wealth of data. Pre-repair scanning mines this data to help focus diagnostic troubleshooting.

The powertrain control unit (PCU) sends commands to the electronic stability program (ESP), electronic brake force distribution (EBD), anti-lock braking (ABS), traction control, brake assist system (BAS), pre-charge brake, and many other systems, depending on the as-built features on the Mercedes-Benz model you are repairing. To do this, the PCU depends on inputs from the electronic stability program. The ESP control unit processes data from rpm sensors on all four axles, the brake vacuum sensor, stop lamp switch, accelerator pedal sensor, and other input sources.

The ESP control unit then transmits actuation signals as needed to the drivetrain control unit, supplemental restraint system (SRS) control unit, brake pedal signal, left and right electric parking brake actuator motors, and the electrical ignition lock control unit. If the PCU sees an out-of-parameter signal from any of the input sensors, or a component not responding within specification to one of the actuation commands, it stores a fault code for the affected sensor, component, or system.

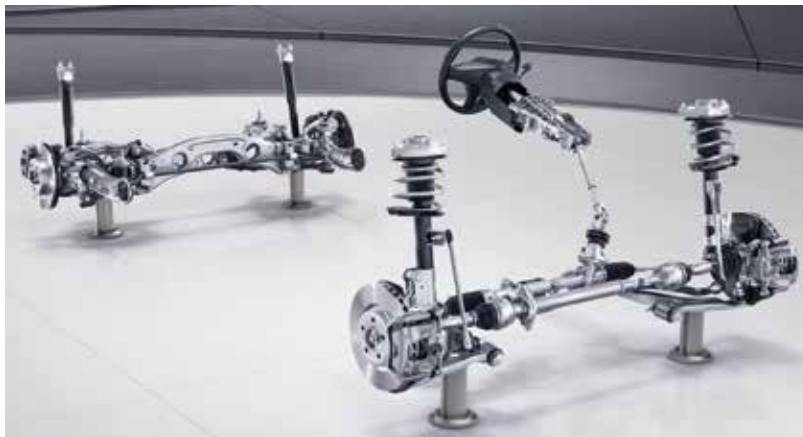
Damage to the adaptive damping system (shown here from the Mercedes-Benz GLA) affects electronic stability control and steering. Pre-scanning narrows the diagnostic path, and post-repair scans help catch additional work, such as steering angle sensor calibration that you must do before delivering the vehicle to the customer.

Leaks or obstructions in air tubing, loose or failing height sensors, and damaged air springs are just a few examples of collision damage to air suspension components. But you must also consider the possibility of electrical problems in the control circuit, the compressor or vent solenoids, air spring solenoids, or the compressor relay.

The good news is that some Mercedes-Benz air suspension systems feature self-diagnostic capabilities. A pre-repair scan for fault codes helps narrow the diagnostic path so you don't start replacing air suspension sensors or solenoids prematurely.

Changes to ride height affects caster readings. Out-of-specification caster readings lead to electronic stability control and steering problems. Checking ride height and air suspension dynamics is a good pre-alignment strategy.

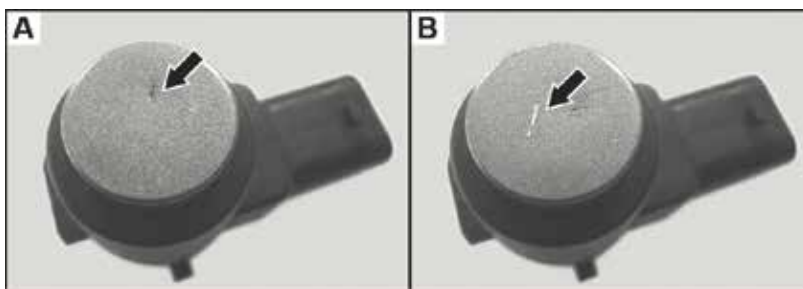
Minor stone chip damage (images “A” and “B”) can reduce Parktronic sensor effectiveness.

damage. Even nicks and scrapes that appear minor can harm Parktronic sensor performance. Use close visual inspection to confirm correct position and angle of each sensor during replacement installation.

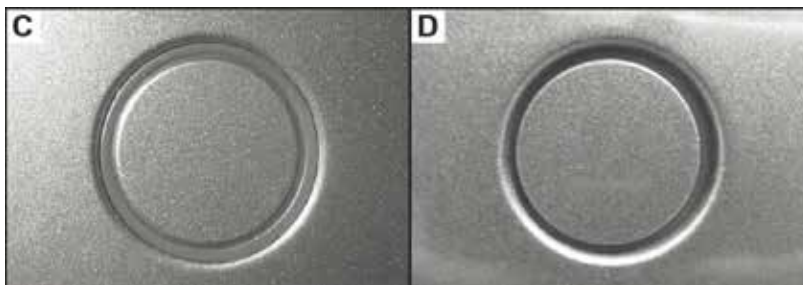
The decoupling ring that positions the Parktronic sensor looks like image “C” when correctly placed. The Parktronic sensor in image “D” is not centered.

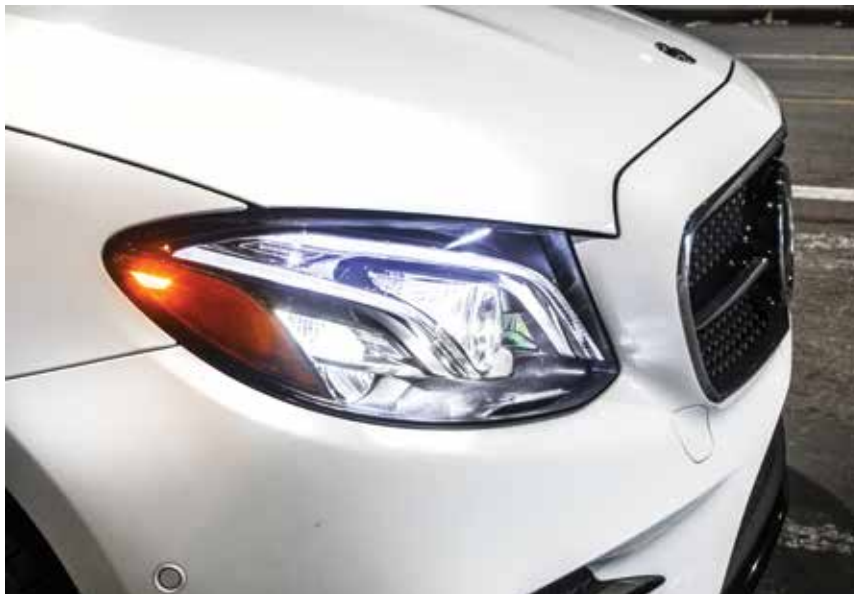
LED and other advanced technologies allow this 2019 Mercedes-Benz AMG E-53 to increase brightness from individual subsections of the front headlamps to provide precise directional targeting of the road ahead. The dynamic lamp can simultaneously cast shorter and longer lengths of light from the same headlamp, so the driver can see what is immediately ahead without blinding oncoming traffic up to a half of a mile away. It can throw part of the light straight ahead and another portion in the direction the vehicle is turning, to illuminate the inside of the curve.

Dynamic lamps can also automatically adjust the amount of light based on vehicle speed. In stop-and-go traffic, the headlamps are activated at lower switch-on points to ensure that the cornering lights turn on early enough to cover the shorter turning radius of urban driving.

Dynamic lighting control uses inputs from wheel speed and steering angle sensors, as well as the turn signal function.
