Timing Chain Tensioners

Rattles and startup noises? While Mercedes-Benz arguably makes the longest-lasting engines of any carmaker, eventually parts wear out. Find out fast if cam timing has jumped.

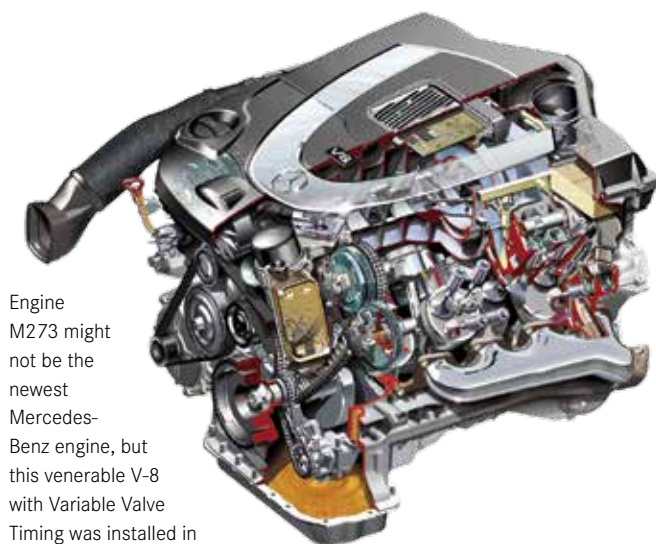
Engine M273 might not be the newest Mercedes-Benz engine, but this venerable V-8 with Variable Valve Timing was installed in millions of vehicles.

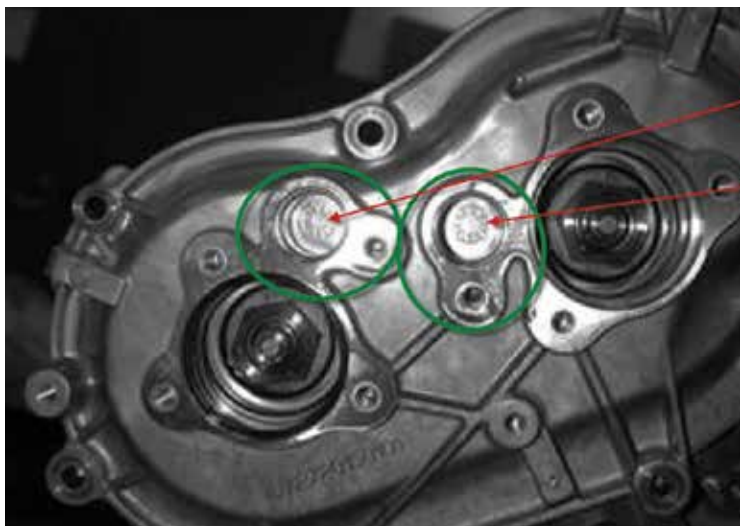
Camshafts in time with stamp centered

Checking cam timing in M272 or M273. Look closely, the stamped circle of numbers should line up exactly in the center of the windows.

camshafts and their relationship to the crankshaft. The cause may be a worn sprocket on the balance shaft on the M272 engine, or a worn idler gear on the M273 engine. To confirm this you will need to do a quick cam timing check. Remove all the camshaft hall sensors and rotate the crankshaft balancer to the 305 degree mark with the front cover pointer. Now you can check the impulse wheels to see if they are properly lined up. The stamped numbers on the impulse wheels should be centered perfectly in the camshaft hall sensor openings. If you find that they do not line up properly it is time for some disassembly for further inspection. Note that you may have to rotate the crankshaft a second revolution to see the stamped numbers.

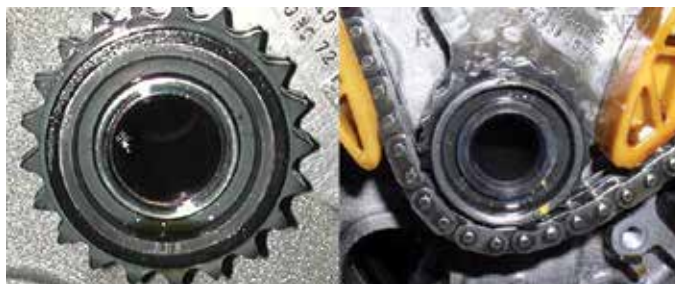
Note how the teeth on the new gear compare with those on the old gear.

Remove the right timing case cover on the engine and, using a borescope, perform a visual inspection of the teeth on the balance shaft sprocket (M272) or the idler gear (M273), depending on which engine you are working on. If you read out those fault codes, the teeth will likely show some wear as seen in the photo. This wear is causing the misalignment of the camshaft timing and the cause for your DTCs. In rare cases a stretched timing chain might be the reason for the fault codes when the sprocket doesn't show any evidence of wear.

If the gear is worn, it will require replacement of the balance shaft on the M272 engine or the idler gear of the chain drive on the M273 engine. It should be noted that at this juncture you need to do a serious evaluation of the entire engine and vehicle. Since this is a 25-hour plus job, consideration of a Genuine Mercedes-Benz replacement engine may be warranted. Note that Mercedes-Benz offers complete parts kits for the job: See XENTRY TIPS document LI03.30-P-050027 for the part numbers.

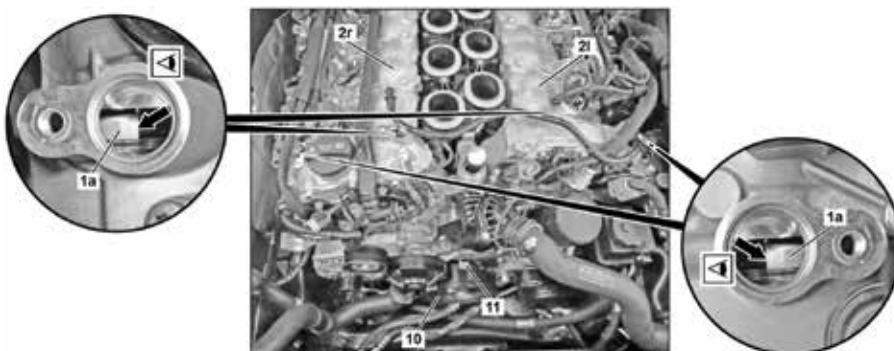
To check basic timing, look into the bores for the hall-effect sensors. The edge of the sensor wheel should be aligned in the exact center of the bore.

If you perceive proper operation of the camshaft adjusters, then proceed with a manual check of the engine timing. This operation is outlined in WIS repair operation AR05.20-P-6010EL. Start by removing all the hall-effect sensors on the camshaft housings. Note that some models will have a 53 degree mark on the crankshaft pulley and some will have only the 40 degree mark.

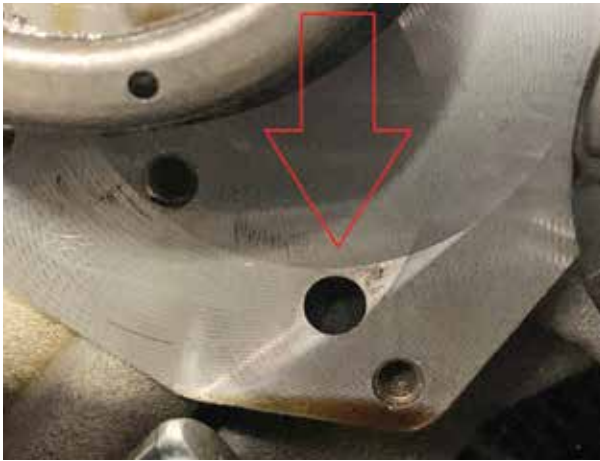
The oil passage seen here does not have a check valve installed.

Upon removing the tensioner you will have access to the oil feed hole where the check valve is installed. Inspect the hole: Some are straight in and some are stepped, and each uses a different valve. Install or replace the valves; for the price, we are way too far into this to not do that.

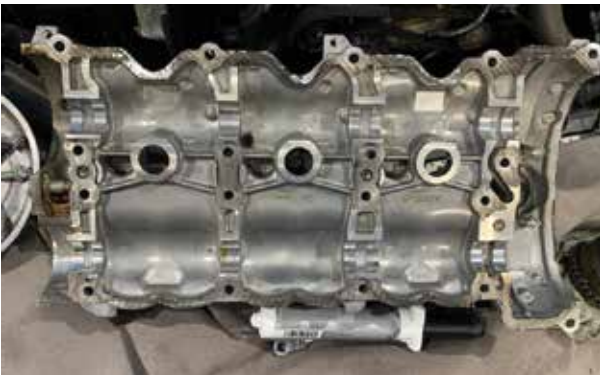
The valve cover castings also serve as the upper camshaft bearings. To prevent damage to the camshaft, mounting a special hold-down tool set (W276 589 01 40 00) is required before removing the chain tensioner.

As the XENTRY TIPS document states, if upon replacing tensioners and check valves you still have rattle it is time to continue with your diagnostics. The camshaft adjusters can be tricky to diagnose, but if you crank the engine over by hand while watching the adjusters with the front access cover off, you might be able to hear an audible "click." Replacing the adjusters is a more difficult operation. WIS repair document AR05.20-P-7201FH lists steps to replace the adjusters. You will need to remove the cylinder head covers for the respective camshafts and mount a special hold down tool for the camshafts, since the valve covers are also the camshaft upper bearings.

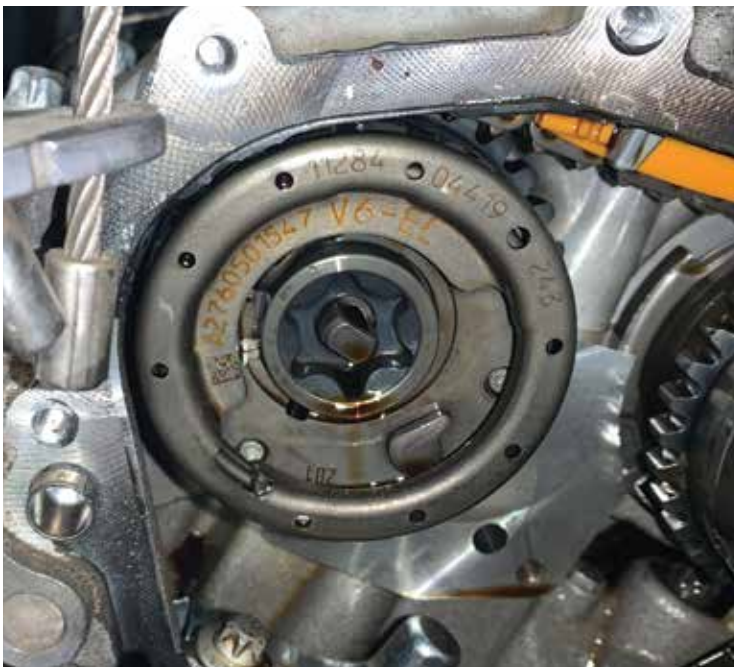
To remove the massive tamper-proof Torx bolt/control valve on the camshaft adjusters, you'll need Mercedes-Benz special tool W271 589 00 10 00.

Remove the chain tensioner to give some slack to the chain, then loosen the center bolt for the adjuster, which is also the adjuster control valve. You will need an assistant to hold the back of the camshaft to help with loosening and tightening of the control valve. Note that this operation is performed with the engine set at the 40 degree mark.
