# the bimmer pub<sup>®</sup>

**Technical Knowledge for Independent BMW Service Professionals**

**Fuel Injectors | Headlight Technology | High Mileage Service | X5 Electronic Throttle**

### X5 Electronic Throttle Drive

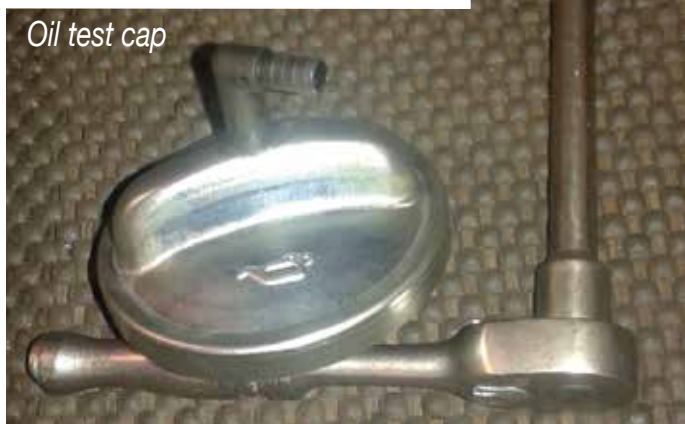
Oil test cap

This indicates the amount of vacuum measured (inches of water).

An aftermarket oil cap was found to fit many BMW and VW/Audi models. The cap was modified by drilling a hole on the top and inserting a new/used elbow from a battery ventilation tube with some JB Weld.

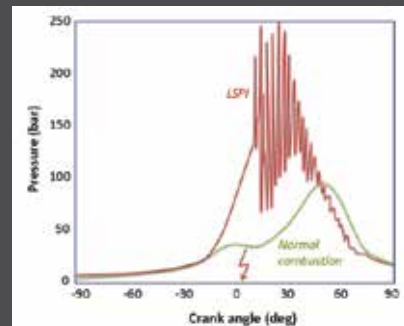
LSPI phenomenon (Courtesy Professor. Dr. Boris Zhmud)

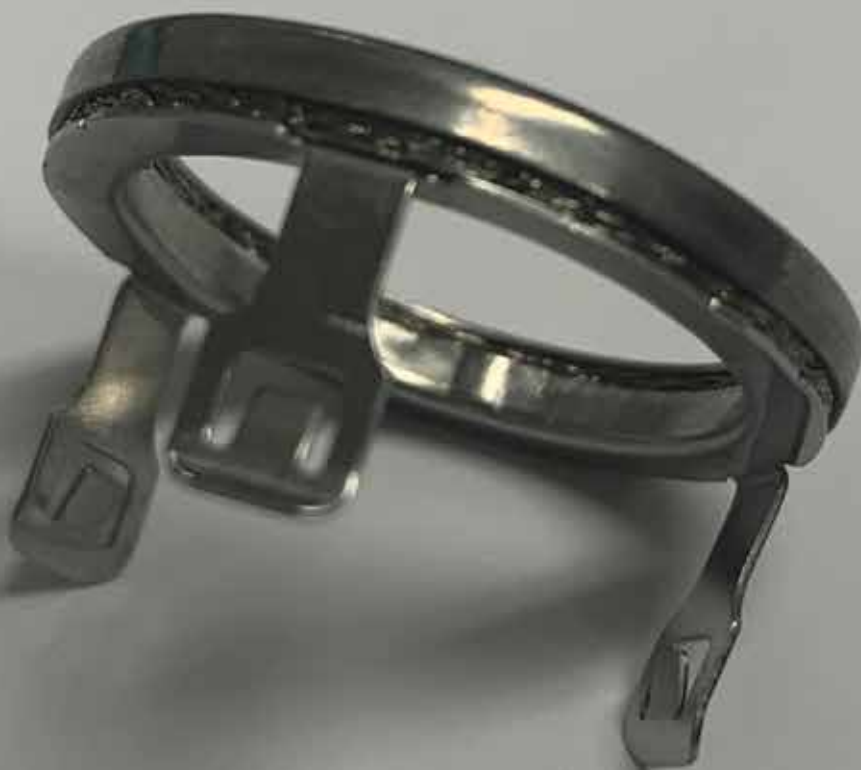
*New decoupling rings must be installed each time an injector is removed or replaced.*

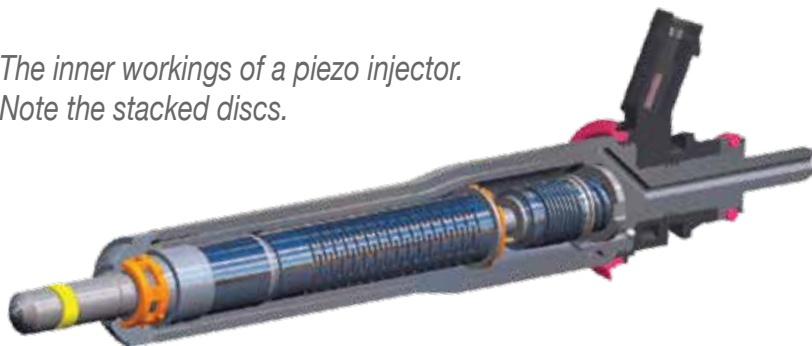
*The inner workings of a piezo injector.  
Note the stacked discs.*

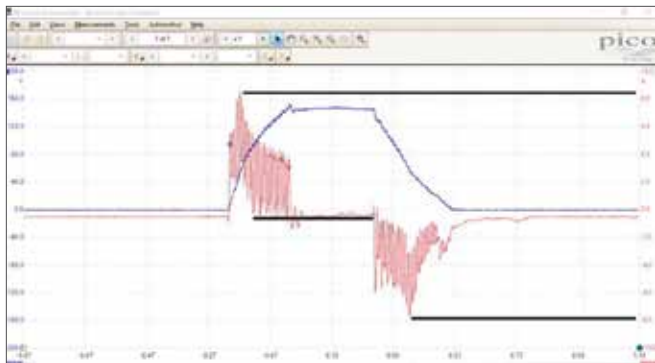
*Your lab scope should graph both the current ramp on and off plus the voltage patterns.*  
(Courtesy Opus IVS™)

Remember, piezo injectors normally operate at extremely high voltages, so use extreme care when working around connections. Do not touch any of the injector terminals while the engine is running. Set your scope to display voltage and current at the same time. Set the voltage range to -200 volts DC to +200 volts DC. Current range should be set around 10 amps. Beginning on a cylinder with no faults, establish a possible known

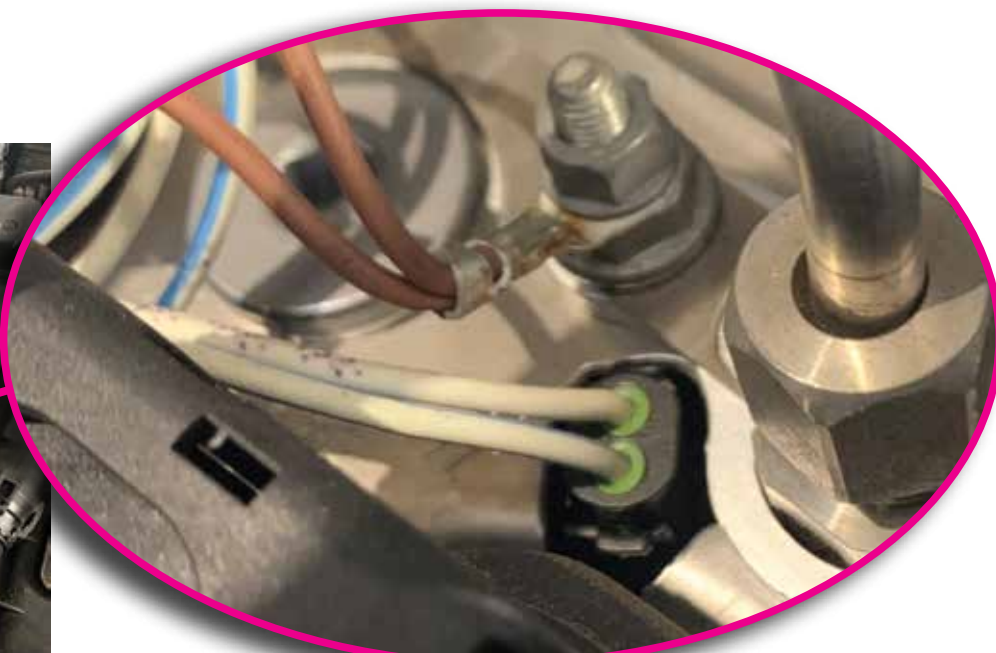
*In the case of this 535 model the injector wires are white.*

good pattern. Insert a back probe into the white wire, then attach your current probe around the same wire. Be sure to consult the wiring diagram for the specific model you are working on.

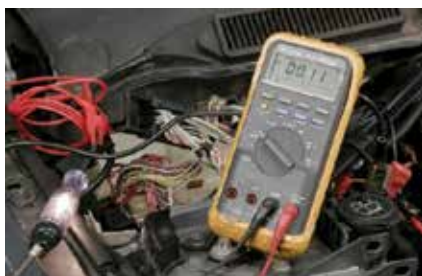
*You should have 0.2 V or less when checking the voltage drop of the injector circuit. (Courtesy Opus IVS™)*

Now that you have identified the correct wire, connect the injector side of the wiring harness to battery negative. Then, at the DME side, connect a test light (the load) to the injector terminal to be tested, then connect it to battery positive. You can use the jump start terminal if you wish, and the test light should illuminate. Use your voltmeter now and check the voltage at the DME connection and you

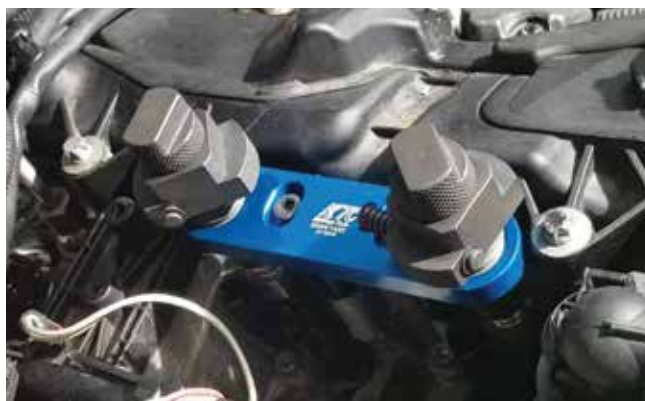
*This removal and installation tool is needed for the N55 engine. With N54 engines you can use the slide hammer type puller.*

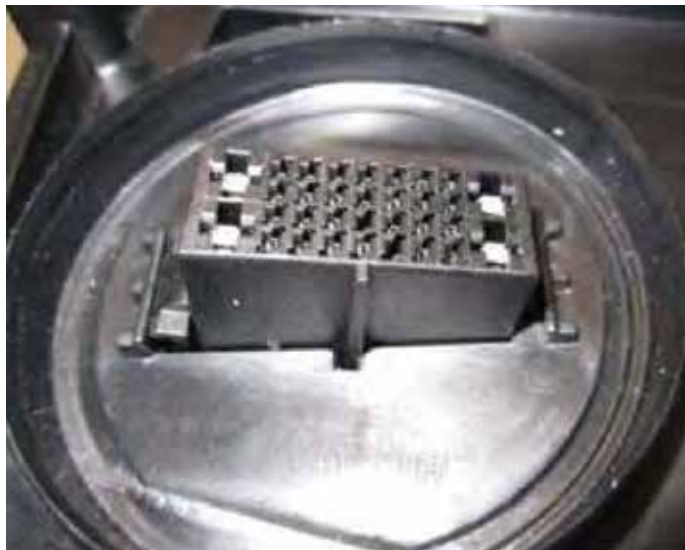
*On the LED headlight, check to confirm that the connector is down to the position shown in the picture. If it is not, push the connector all the way down.*

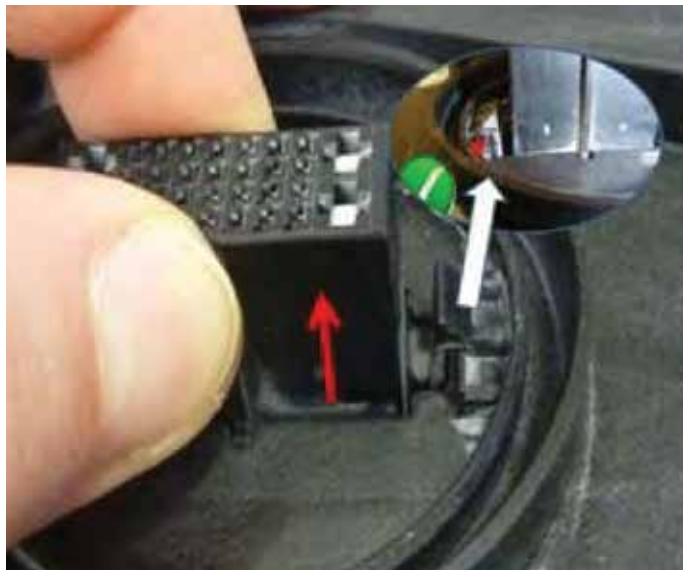
*Lift the connector up until you hear a clicking sound. The click means the locking tab has engaged and the connector is properly and securely positioned.*

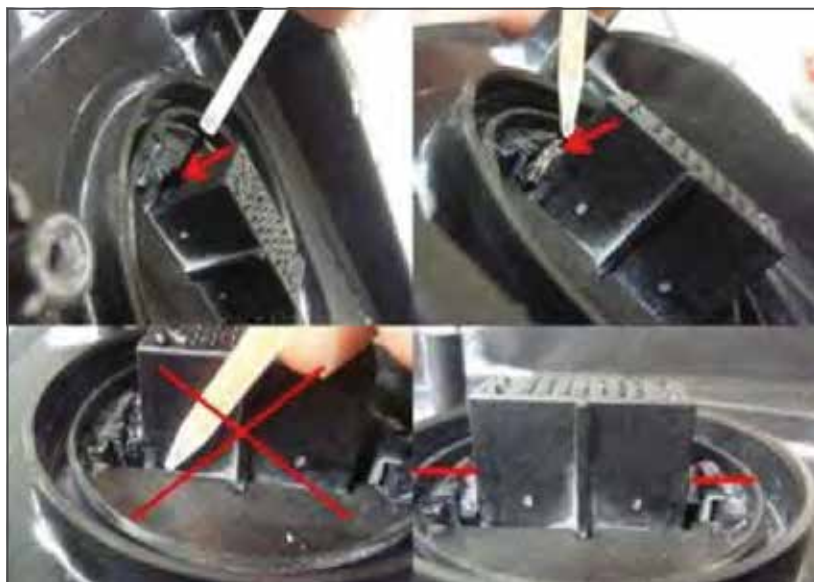
*Apply adhesive behind the tabs (see red arrows in picture) on each side of the connector. Do not place glue along the long edge of the connector (red “x”). Before applying the glue, clean the area per the instructions from the adhesive manufacturer. Apply adhesive to both sides at the same time, and only after the tab is in its locked position. After ten minutes of drying time, reconnect the LHM on both sides. Confirm that the headlight works before completing installation into the vehicle. Reinstall the front bumper and delete any stored headlight fault codes.*

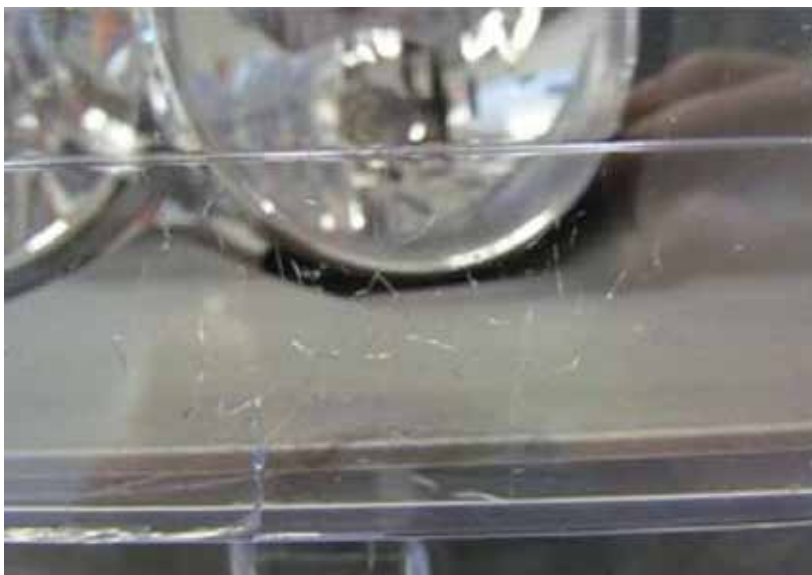
*BMW X3 models produced from October 2010 to June of 2012 may develop stress cracks in the headlight lens covers. The cracks often begin at the lower edge of the lens cover and spread upward.*

Second-generation BMW F25 (X3) models produced from September 30, 2010 to June 21, 2012 may experience stress cracks in the headlight lens covers. See TIS bulletin SI B63 03 13 “Stress Cracks in Headlight Lens Covers” published in March 2013 for details.

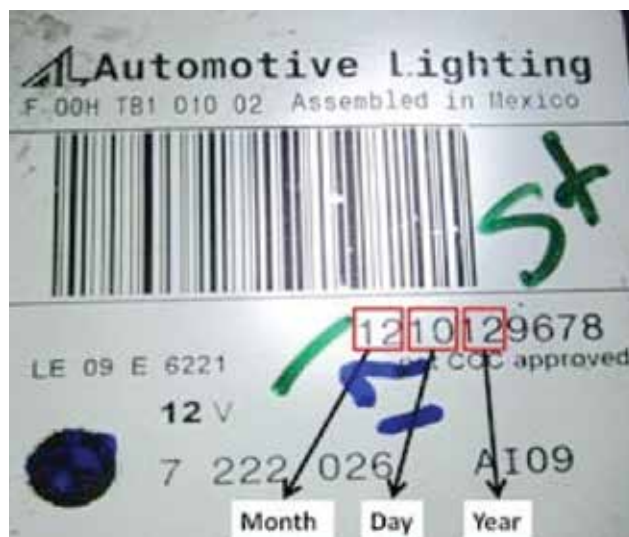
*Install only headlights produced in November, 2012 or later. They feature a new, more crack-resistant design. In the sample label here, the production date is highlighted in red. The first two digits are the month, the third and fourth are the day, and the fifth and sixth digits are the year.*

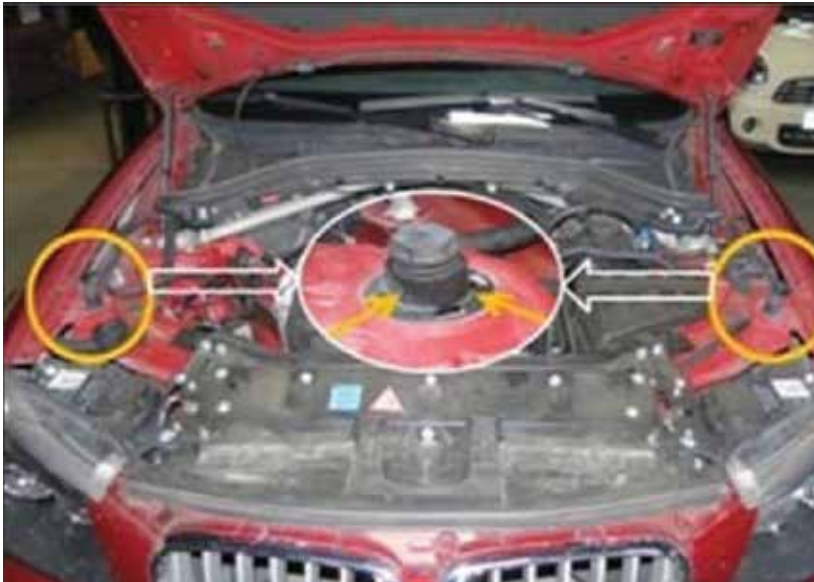
*If bump stops (pedestrian protection buffers, circled in yellow) are damaged or incorrectly positioned, they may allow the front end of the hood to press down excessively on the headlight housings, causing cracks and fissures in the lens covers.*

This fault in the lens cover material has two different potential causes. One is bump stops (pedestrian safety buffers) that are cracked, misaligned, or missing, and cause the front of the hood to weigh down excessively on the headlight lens cover. Another source of stress is old design hood lip seals that

After replacing the headlight, check and replace any cracked, misaligned, or missing bump stops. Refer to ISTA REP

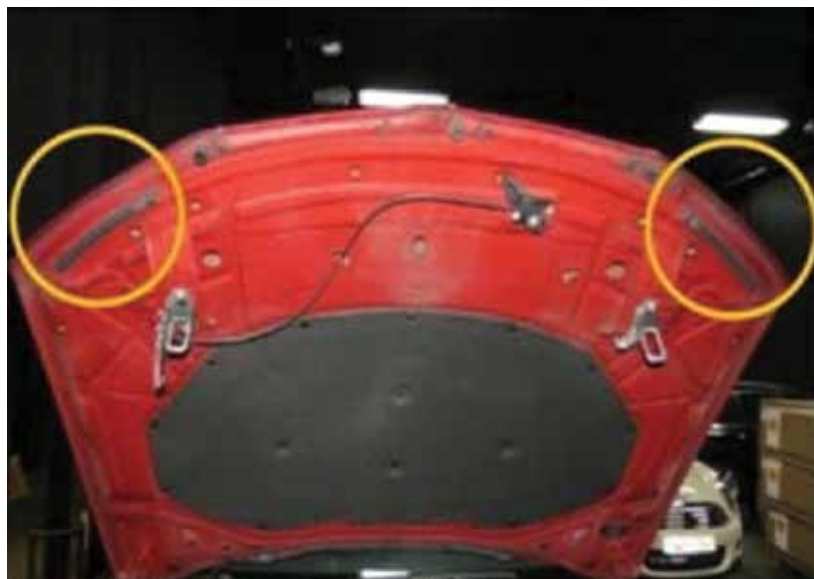
*Replace the old design seals (see yellow circles) on the left and right sides of the hood front lip with new dual-chamber reinforced sealing.*

Beginning with June 20, 2012 production of the F25, BMW introduced a new dual-chamber, reinforced seal designed to prevent the front lip of the hood from applying excess pressure on the headlight housings when closed. If you are working on a vehicle with the pre-June 2012 seals, replace them with the new design. After your repair, check to make sure the hood does not come into contact with the headlight housings.

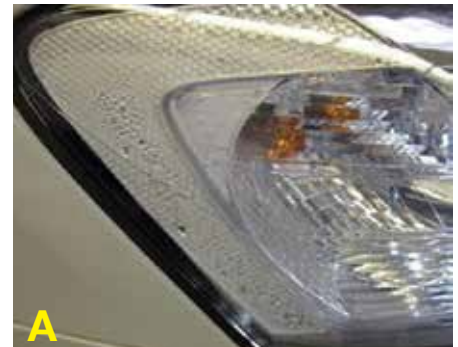
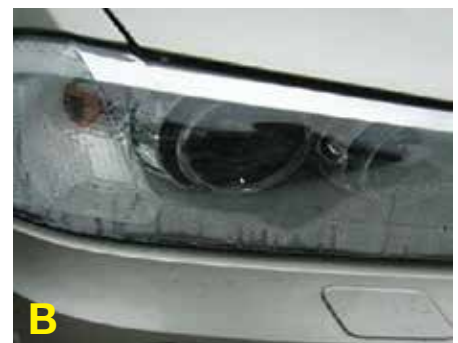
*Large droplets of water (A) inside the headlight lens cover are caused by leaks passing through failing seals or cracks in the housing. A fine mist (B) is due to the natural process of condensation.*

This problem can be caused by either a moisture leak into the headlight housing or condensation. How can you tell which has occurred? A leak will appear only on the headlight side that has a weakened seal or cracked housing. If the problem is due to condensation, you will see misting in both headlights. Additionally, a leak shows large droplets, while condensation appears as a fog or mist.
