STARTUNED®

Fiber Optics D2B and MOST Bus

How they
work, wake-up
signals, testing
and repairs

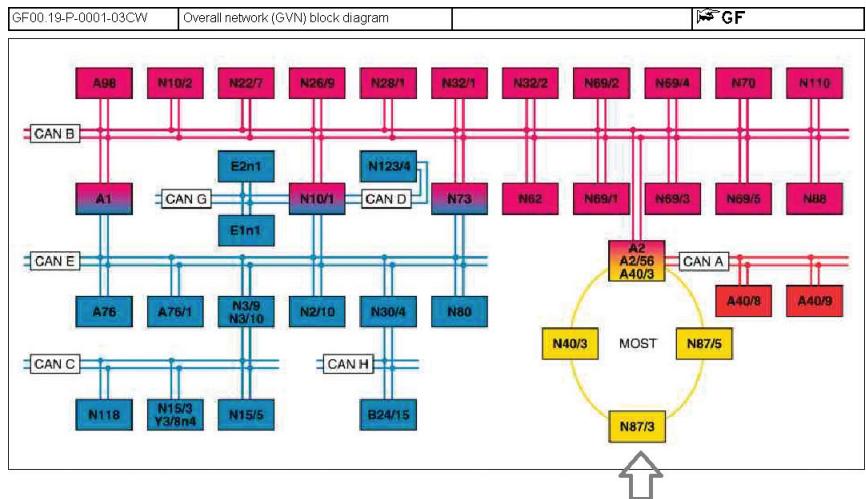
In this typical networking diagram from WIS, note the MOST network ring shown in yellow.

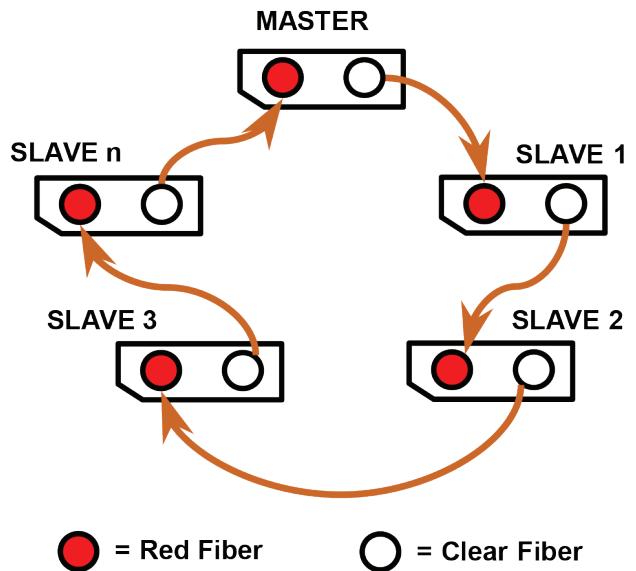
Light in a D2B system travels in a loop, from one component to the next, with red light visible on the red fiber optic cable end.

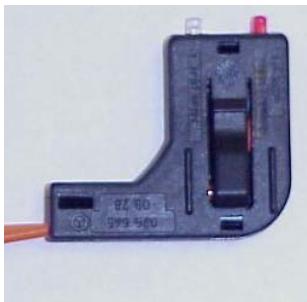
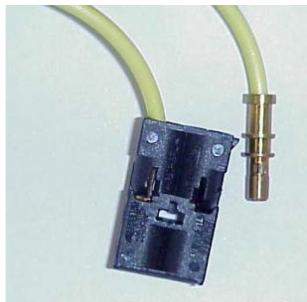
Here we see a 90-degree D2B optical connector, and for comparison two versions of straight MOST connector: Optical-only and Combination. Note the protruding ends of the D2B cables (top), and the uncolored recessed ends of the MOST fibers (top right and right).

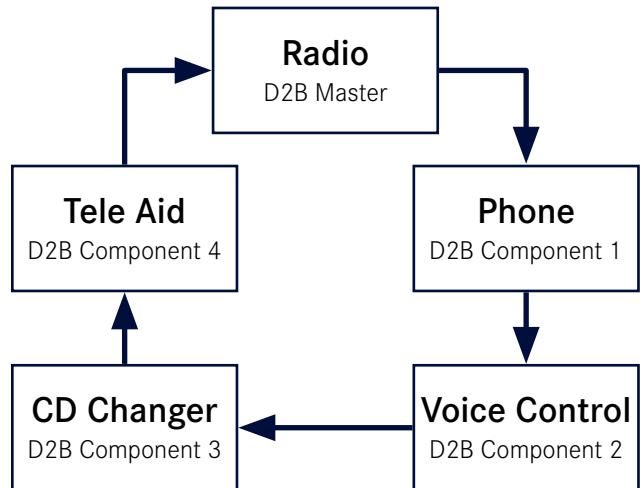
This is an example of the D2B ring configuration for a model 210 E-Class. Not every vehicle will have all of these systems installed. It is critical to ensure the D2B network in your specific vehicle matches the actual vehicle's equipment. The order must be strictly observed or you will have errors; in other words, Tele-Aid (if installed) is always last, Phone (if installed) is always first, and so on.

4. The D2B ring configuration varies according to vehicle type and in accordance with the vehicle’s equipment level. Check the near-by figure to see an example of a configuration. Consult the vehicle data card and WIS to find the correct “as built” configuration of a specific vehicle. Some installations will not include all the components shown in the examples. If a component is not present, connect the preceding component output to the input of the one following the component not present. Once again your SDS or XENTRY should be able to show you the components you already have in the system

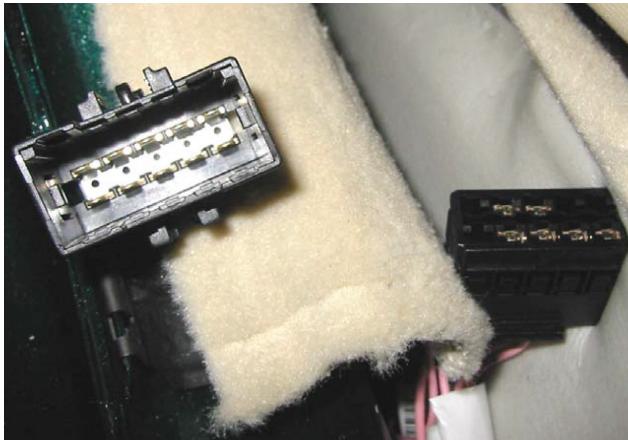
The wake up wiring connector for MOST is found in the driver's side rocker panel. All of the wires to individual components are found here.

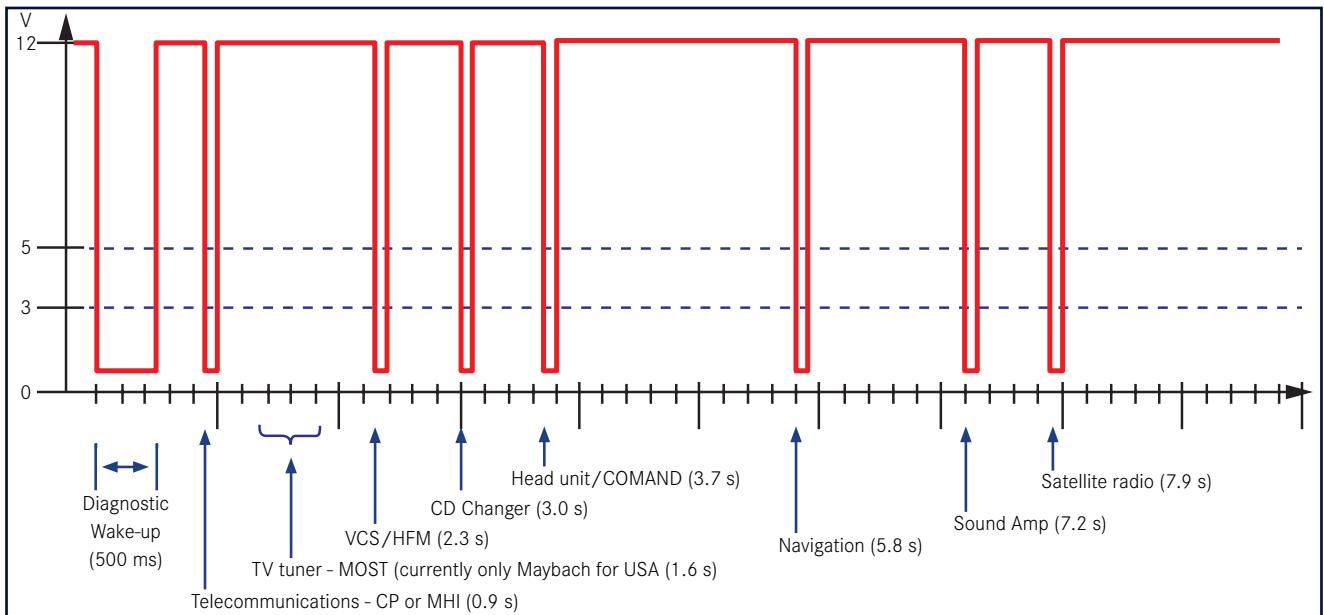
Diagnostic wake-up: By monitoring the diagnostic wake-up line with an oscilloscope (set to 1 or 2 seconds per division), you can see both the diagnostic wake-up pulse (500 ms) sent using XENTRY and the responses from the various control units on the MOST bus. Each component has its own time slot to respond, as seen here. Of course, there will be no response from faulty or non-installed control units. [Values taken from MY2005 S Class (NTG1).]

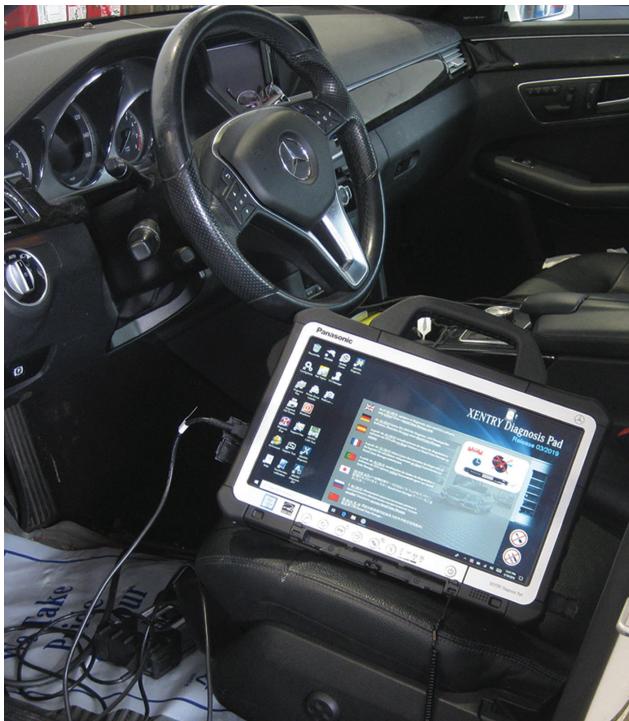
Having a factory tool such as the XENTRY makes simple work of diagnosing the MOST network.

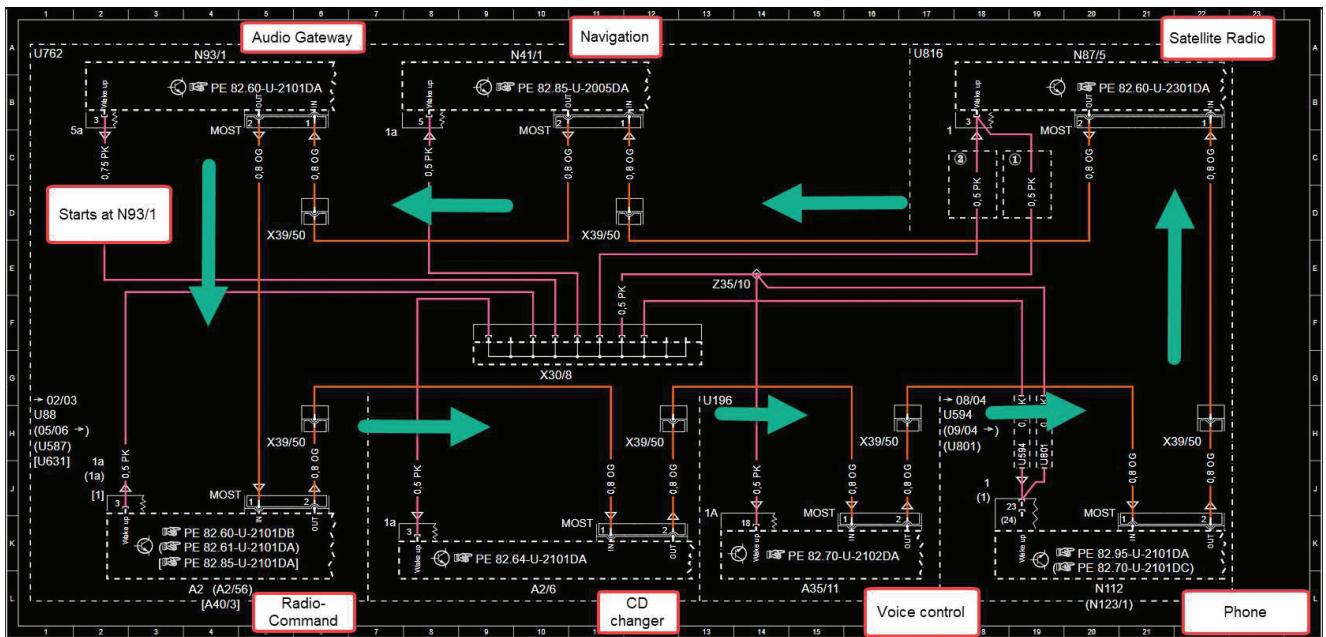
An example wiring diagram for a MOST network. Note how the optical signal flows on the optical fibers from 'out' to 'in' in a ring configuration. The transmitted light is visible and red.

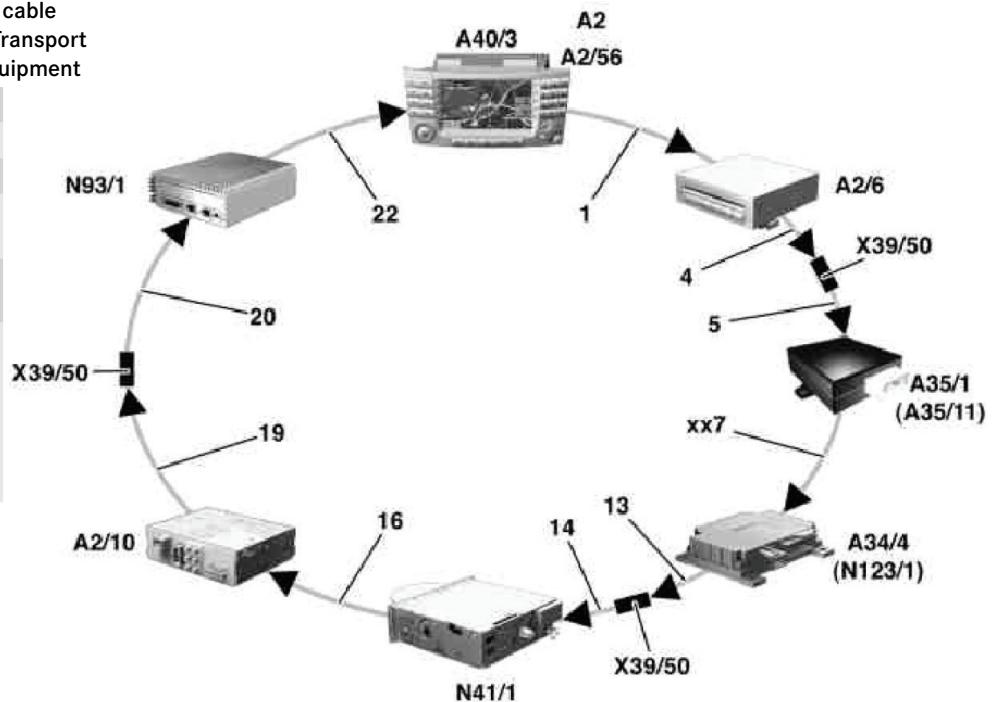
Ring sequence of the fiber optic cable for the Media Oriented System Transport (MOST), shown for maximum equipment

1 to 22	Fiber optic cable modules
xx7	Fiber optic cable module
A2	Radio
A2/6	CD changer (with code (819) CD changer)
A2/10	TV tuner (with code (860) TV tuner)
A2/56	Radio control panel and navigation unit (with code (521) MB Audio 50 radio USA (without navigation) or with code (525) MB Audio 50 APS radio)

An example from WIS showing the maximum-equipment MOST ring component sequence. Note that some components shown are not offered in USA models.

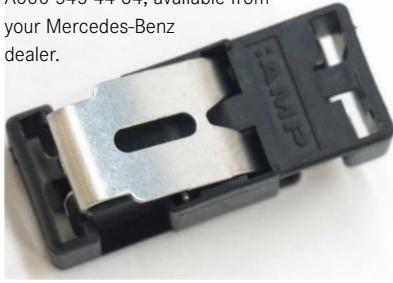
A must-have tool when trying to isolate a problem component or removing a component is this in-line optical splice, A000 545 44 84, available from your Mercedes-Benz dealer.

Perform a wake-up line test in actuations to determine if a component on the ring line is not responding. A MOST splice connector can be used to bypass the component (Mercedes-Benz Part A000 545 44 84 available from your Mercedes-Benz dealer) to see if audio comes back. If audio

responding. You will have to install the splice connector in each component in its order to eliminate the culprit.
