X Marks the Spot, Part 2

What to be aware of when servicing and repairing BMW's Sports Activity Vehicles and Coupes.

Technical Knowledge for Independent BMW Service Professionals

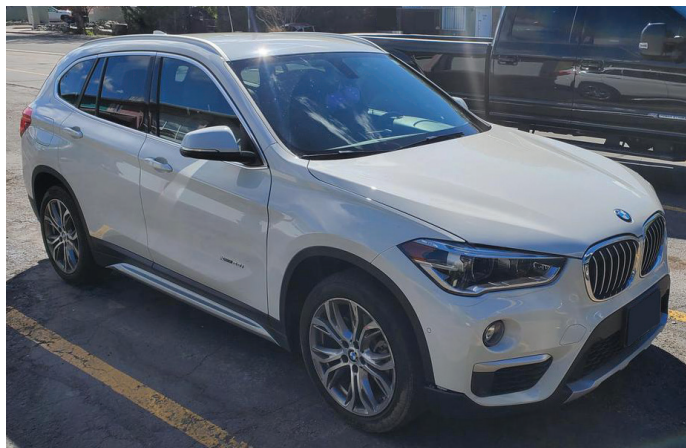
X1 with Hofmeister Kink and Kidney Grilles

All these vehicles push boundaries in the spirit of performance and excellence while holding true to classic design features like the Hofmeister Kink (the forward angle at the bottom edge of the rear quarter window, named for prior BMW chief of design Wilhelm Hofmeister), dual front kidney grilles and aggressive stance.

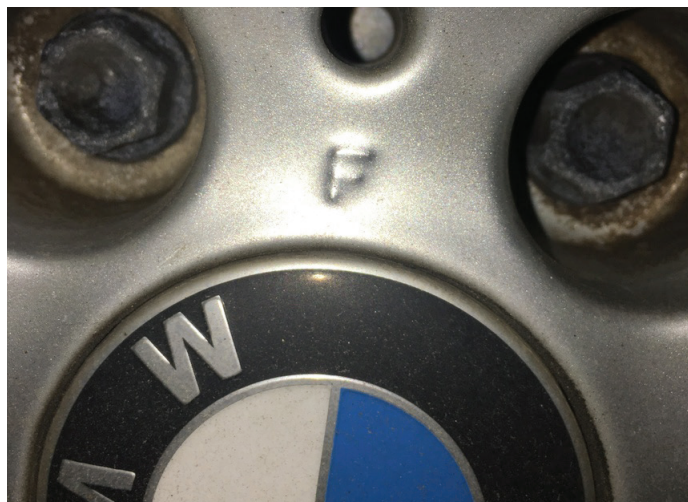
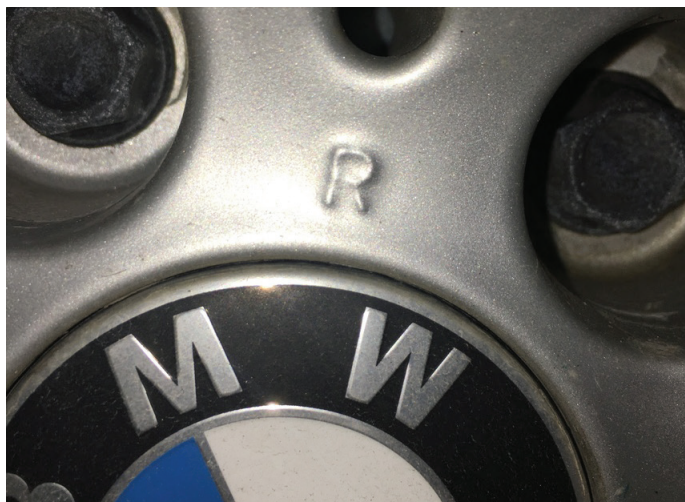
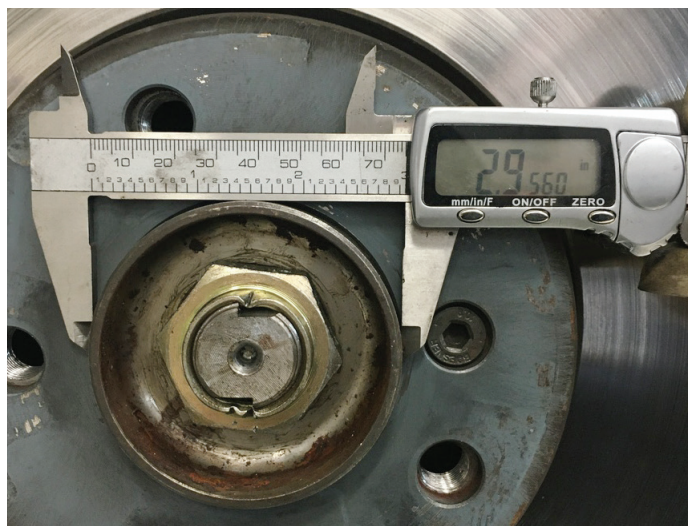
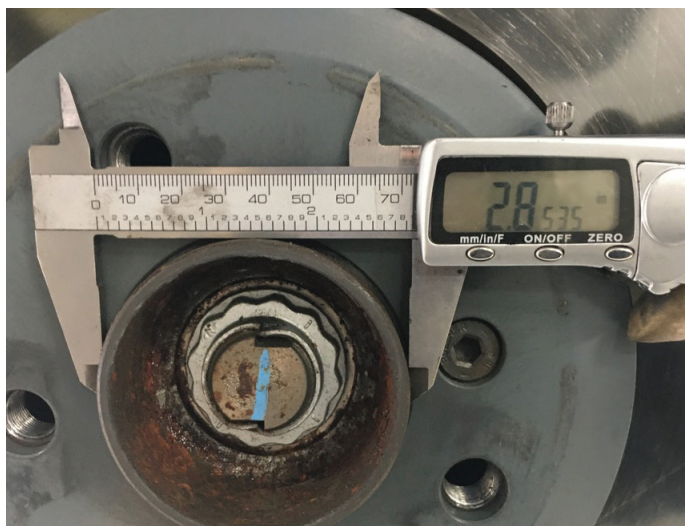
The front hubs on our BMW are slightly larger in diameter than the rears, and the rear wheels have a slightly smaller bore than the fronts so the rear wheels will not fit on the front. Small letters F and R help to identify the wheels.

Back on the X6, the technician continued by checking tire pressures and found that several of the tires were underinflated. There were no obvious foreign objects in the tread or damage to the tires, so the pressures were adjusted to specifications. Next up was the tire rotation. The tires were unbolted and removed, but when the technician tried to rotate the rear tires to the front it was discovered that the wheels would not fit on the front hubs. Further investigation found that the front hubs were larger in diameter than the rear, and the wheels were marked with a small F and R to indicate Front and Rear.

BMW service information states that wheels may be exchanged between sides to achieve even tread wear, but they do not recommend rotating wheels front to back on their vehicles. In BMW's words, this is due to "complaints regarding acoustics" and a "risk of increased lane groove sensitivity" that may be experienced when the rear tires with different wear patterns are moved to the front. This is contrary to the older thinking of not cross rotating radial tires and is further complicated by rotational tires which would be turning in the wrong direction if moved to the opposite axle. The only option to rotate the tires on our case vehicle would be to dismount and reverse each wheel on its rim before moving it to the opposite side. While this can be done, it is quite impractical, with the costs cancelling out any potential savings from extended tire life.

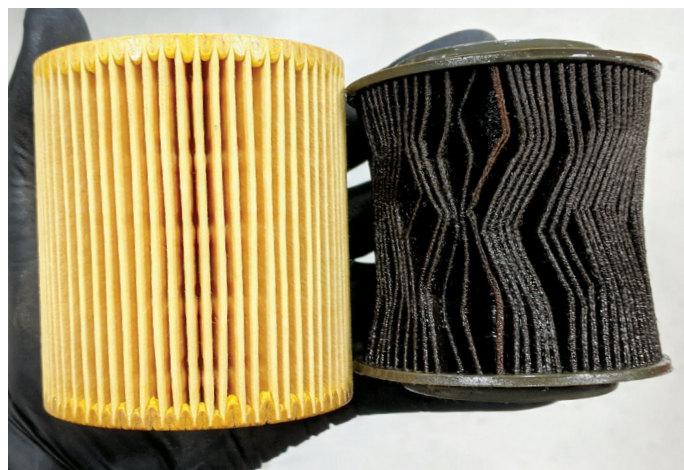
Comparing Oil Filters

The heart of any of the X-series vehicles is the engine, and the lifeblood of those engines is the oil. As engine tolerances get smaller and power outputs go up, the oil and filter quality have become more critical. Driving past the recommended service interval and using poor quality, non-OE oil filters can result in costly engine repairs down the road.

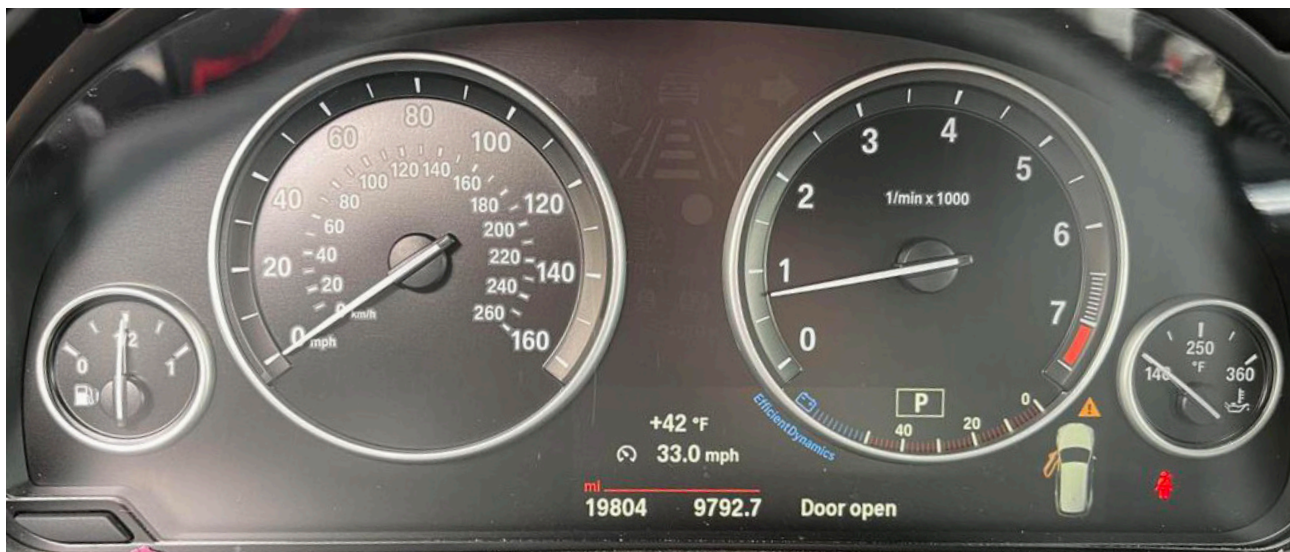
2018 X5 Instrument Panel

Reviewing the full pre-scan report on the 2018 X5 showed that all the faults were listed as intermittent, and not current issues that needed to be addressed. This fact was further confirmed by verifying there were no warning lights or messages displayed on the instrument panel.

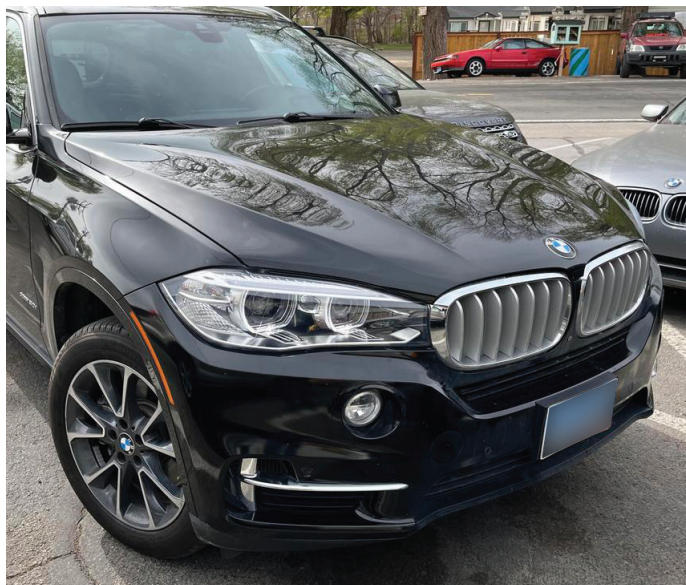
2018 X5 Parking Sensors and Front Camera

faults dealt with the front camera on the vehicle and mentioned camera blindness, overheating, and a connection issue. While performing the service, the technician visually inspected the front camera to see if there was anything restricting air flow or blocking the lens. Nothing unusual was found on this X5, so after the service was completed a final note was added to the work order stating that:

The open circuit faults for the ultrasonic sensors were mildly concerning, but further discussion with the client revealed that the front bumper had recently been removed and repaired after a minor fender bender. The remaining

“There were multiple faults on the vehicle pre-scan for the front camera and front distance sensors. Client states the front bumper was recently removed which is the likely cause of the open circuit distance sensor faults. No visible issues were found with the front camera at this time. The faults were cleared from memory. If codes return, further testing will be required.”
