Technical Knowledge for Volkswagen[®], Audi[®] and Porsche[®] Service Professionals

AUDI FSI NO START AND SUSPENSION FAULTS

By: Augie Ferron

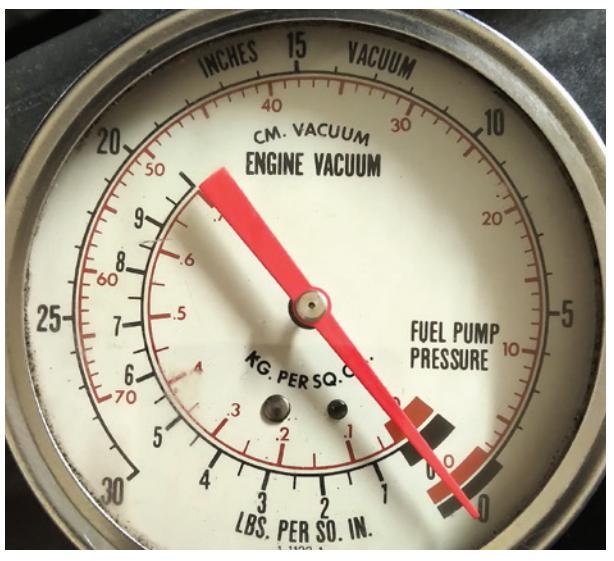
Vacuum test

A guick and simple cranking vacuum test offered no indication of any PCV or oil separator damage and there was one anomaly no dipstick. It would appear the "pretend plug" is an option and oil measurement is via instrument cluster display. A special tool called a "Chrysler transmission dipstick" was employed to measure a heavily over filled crankcase.

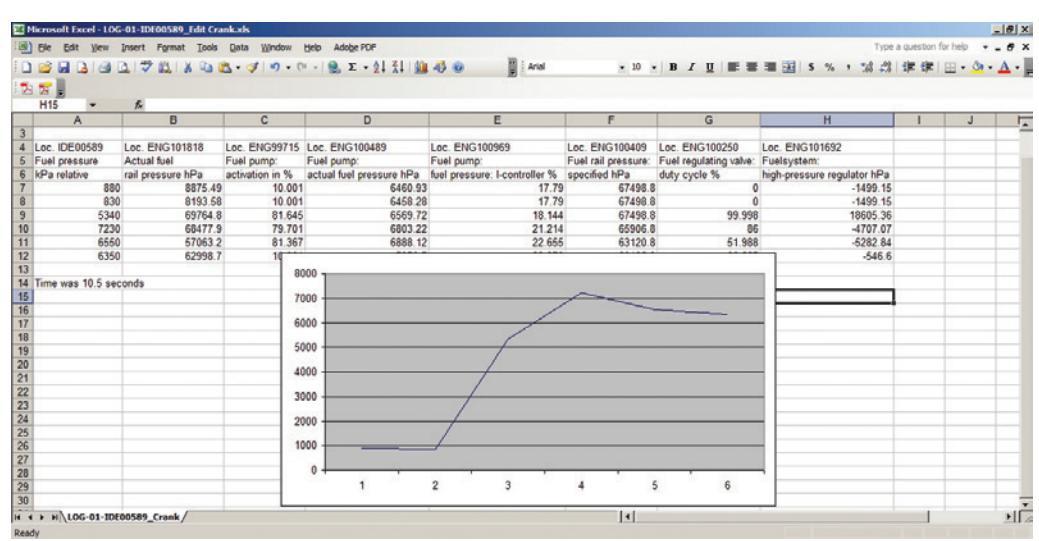
Cranking test

Sitting in the vehicle with the laptop or tablet, these values offered a hint that the fuel system was operating, but is there another view that will offer "pressure build up" versus cranking time? Saved again with a screen image but used the "Log" button.

Sample	Rate: 0.5 VC	DS	
Group	UDS requests Tu	bo!	
Loc.	Description	Actual	
IDE00	Fuel pressure	6820 kPa rel	
ENG1	Actual fuel rail pressure	71184.4 hPa	
ENG9	Fuel pump: activation	72.876 %	
ENG1	Fuel pump: actual fuel pressure	6805.87 hPa	
ENG1	Fuel pump: adaption value	0.000 %	
ENG1	Fuel pump: fuel pressure: I-controller	14.929 %	
ENG1	Fuel rail pressure: specified	63617 hPa	
ENG1	Fuel regulating valve: duty cycle	61.977 %	
ENG1	Fuel supply system: high-pressure regulator	-8506.68 hPa	
G	raph Log	Save	Done, Go Back

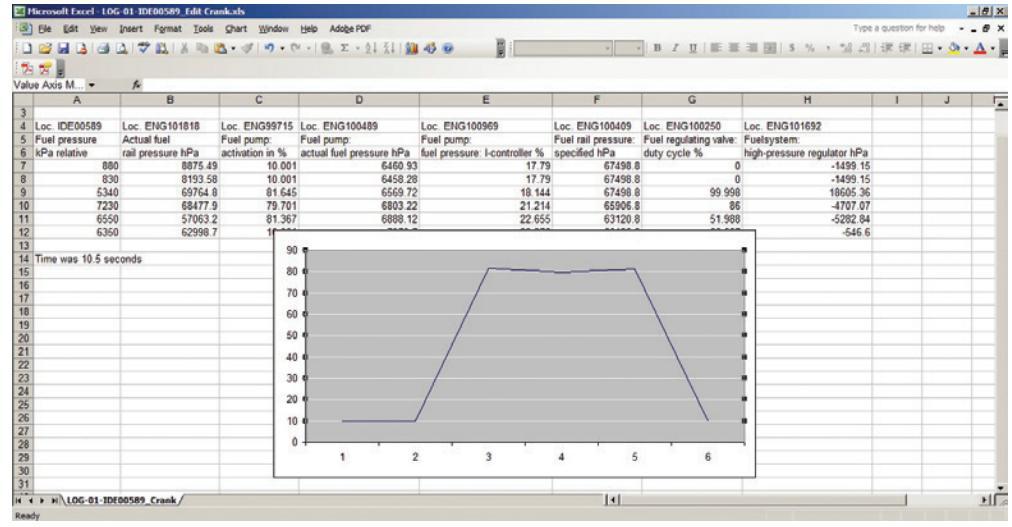
I-controller percent

The next test was with another ID of interest: ENG100969 Fuel pressure I-controller offered that the ECM was in control, attempting to increase pressure during the cranking stage.

The same log was used and graphed the specific column ENG100969.

Lastly the internal fuel pump within the fuel tank ID ENG99715 is the ECM command via fuel pump control module during a cranking event.

Diagnostics from the driver's seat and the engine may not have started, but at least the fuel system operated as intended. It's assumed there was decent fuel in the tank.

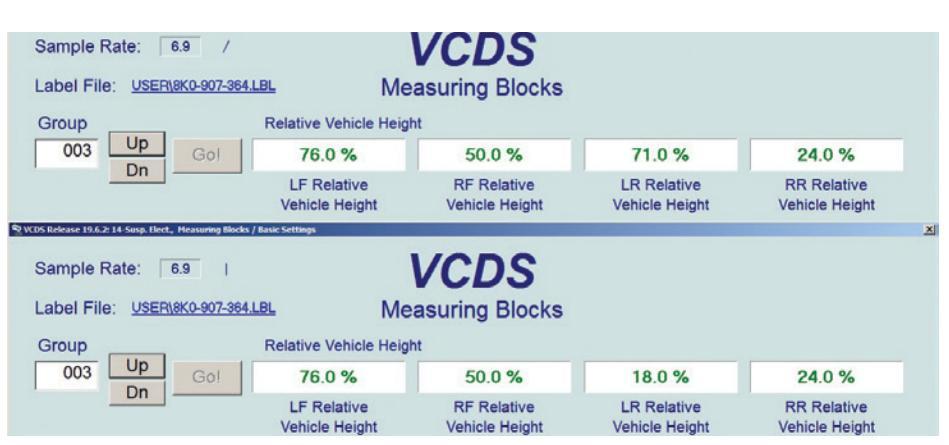
Left rear sensor

With a decent label created and now measuring the system via hoist up and down movements, other damage was found but no fault recorded. The images indicate a movement at the left rear sensor and this time with hand movements.

This damage was not created by the tow vehicle; this is called rust/salt and not looking after or maintaining the A4.

The A4 owner wondered how it was possible to have that data but opted out of the recommended and additional repairs for the moment.
