About Subaru Water Pumps

Myths and Maladies

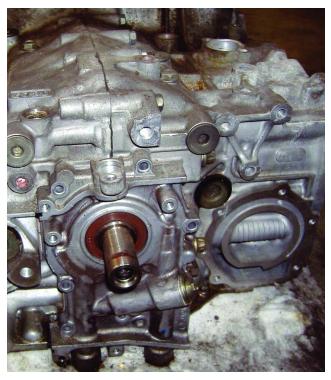
Looking into the water pump cavity, you can see that the Subaru engineers placed the pump as low as possible in the engine.

On Subaru vehicles, the pump is located at the bottom front of the engine, and the thermostat can be found in the lower part of the pump housing. This location provides even engine warm-up because it allows metering of the coolant temperature to be especially accurate. The thermostat senses the temperature of the crankcase and radiator coolant as it is mixed. As you know by now, all of the coolant must be drained to change the thermostat.

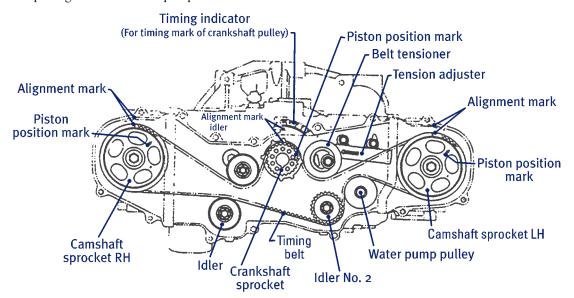
One advantage of driving the water pump with the timing belt is that there's no chance of the engine running without the pump shaft spinning. Ergo, less chance of catastrophic overheating.

Subaru vehicles power the water pump with the back of the timing belt, or, in the case of the 3.0L six, by means of the timing chain (more on this engine later). This makes it impossible to run the engine without the pump shaft spinning, thus avoiding the possibility of truly disastrous overheating.
