# Clean, Straight and Clamped:

## Head Gasket Diagnosis and Replacement

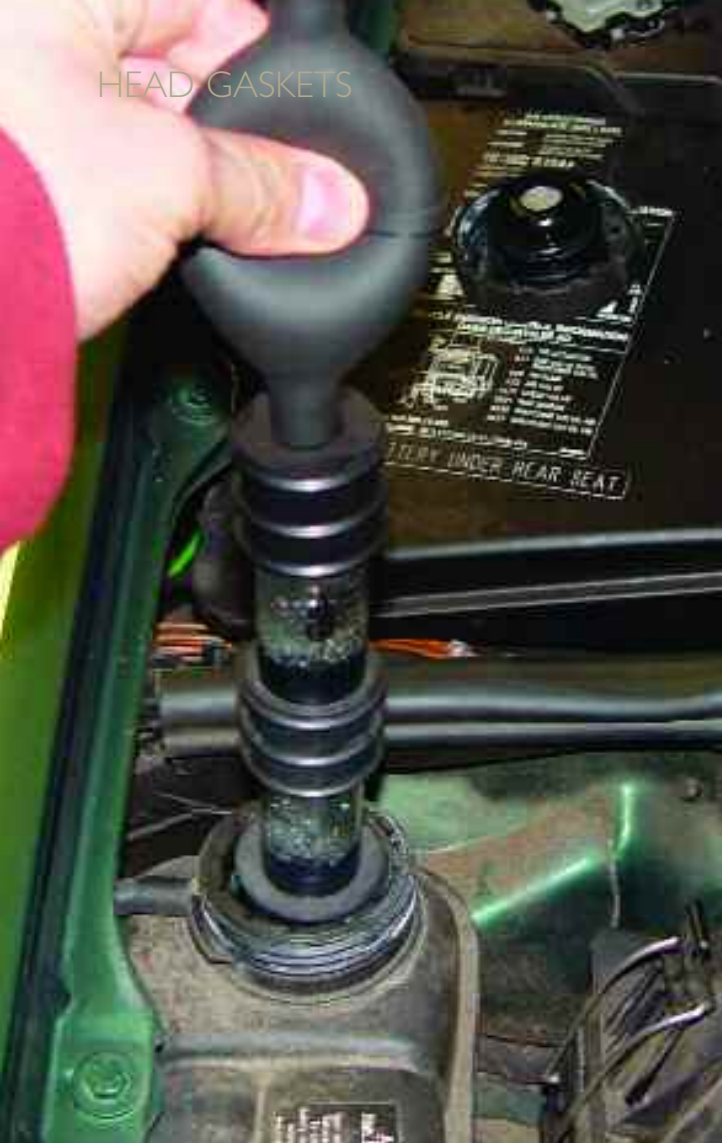
*Using a combustion gas leak detector will allow you to determine if there's a leak between the combustion chamber and the cooling system. Don't forget to drain some coolant out of the system to build up sufficient combustion gas.*

If the symptoms are minor, finding a head gasket leak will be more difficult. The best way to test for a small compression leak is to use a "chemical block tester." This contains a chemical solution in a multiple diaphragm syringe. Gases in the cooling system are drawn into the tool and mixed with the solution. If combustion gases are present, these chemicals change color. To get an accurate reading you need to drain approximately one half to one full gallon of coolant from the system, depending on its total volume. This allows a sufficient quantity of gases to build up in the coolant reservoir and the radiator for the leak detector to work. Overlooking this step is likely to lead to false readings and an erroneous diagnosis.

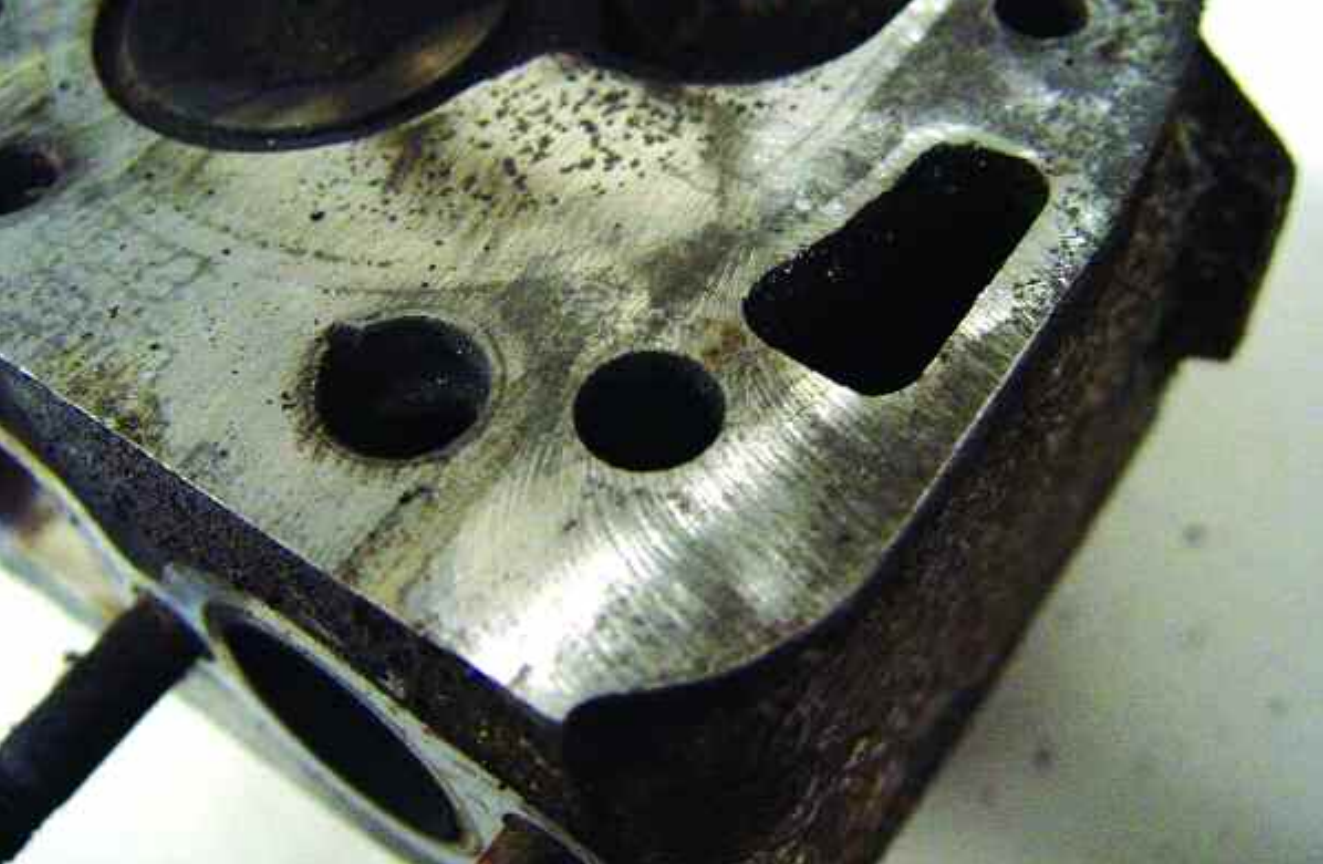
*Here we can see the swirl marks left by surface conditioning discs. If you stay in one portion of the cylinder head too long you can create a dip that the head gasket may not be able to seal. So, clean the cylinder head by hand using suitable scrapers.*

Cleaning the cylinder head gasket surface properly is critical. Aluminum is so soft, it's easy to ruin a head casting with electric or pneumatic tools in a matter of seconds. Do not use Scotch Brite pads on your "whizzer" tool as they will cause gouges and undulations, and leave abrasives behind that can actually damage bearings. Ditto for the sealing surface of the block.

Soaking the head in a distillate solution causes the gasket remnants to soften for easier removal. The use of a properly sharpened gasket scraper, free of gouges itself, will remove most of the material left on the head.

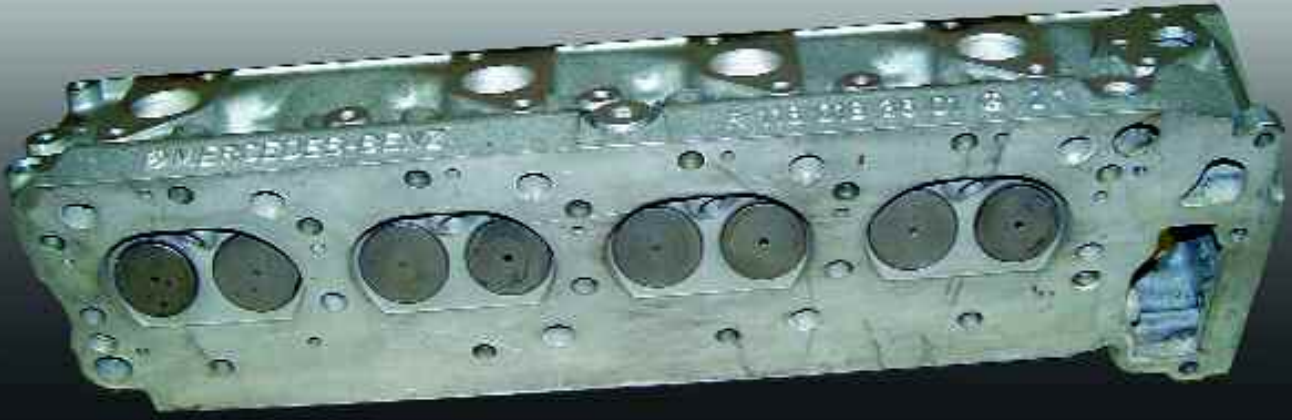
*After cleaning, measure the surface straightness of the cylinder head mating surface. In this case it was necessary to mill the cylinder head, and the head thickness was sufficient to do so. This creates a near ideal surface for the head gasket to seal against.*

Next, accurate measurements must be taken for surface flatness and irregularities. These measurements, along with the overall thickness of the cylinder head, will determine if the casting simply needs to be cleaned, or must be milled or replaced. Hold a straight edge tool against the block and cylinder head in multiple positions and measure the depth of any gaps with a feeler gauge. If excessive "waves" or "ripples" are found, the head or block must be milled to assure a good seal.

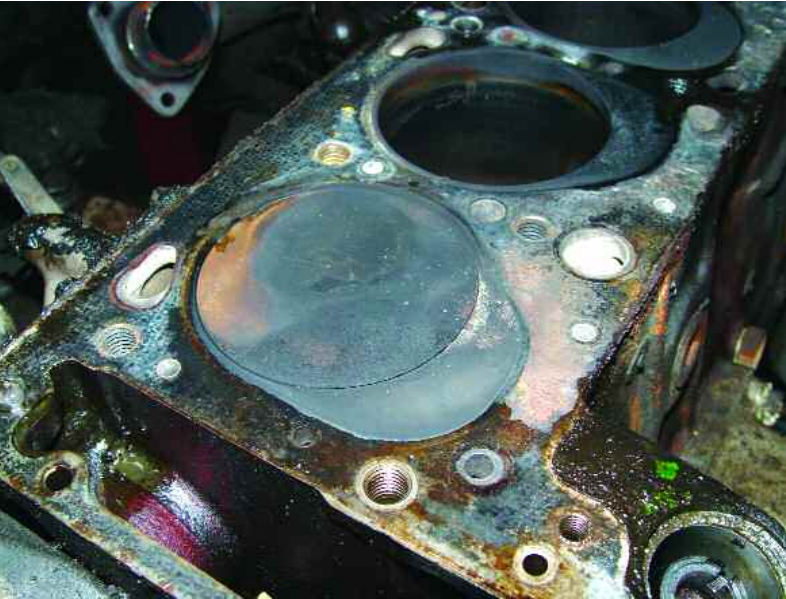
*Look at the two cylinder head bolt holes on this 190 model and you can see that the one on the lower right is cleaner than the one on the left. Do not use a tap to clean bolt hole threads. You will remove too much material. Use thread cleaners or chasers and you will have a secure mating of the thread surfaces.*

You should also be concerned with the head bolts. Since torque-to-yield bolts are used (meaning they stretch), Mercedes-Benz has included a specification on head bolt length. If the head bolt has stretched beyond this spec, then the possibility exists that the bolt will bottom out in the block and the head bolt will not apply the necessary clamping force to the cylinder head allowing it to warp when the engine gets up to operating temperature. Or, the bolt may simply snap, which would result in a time-consuming extraction job.
