KEEPING THE ELECTRICALS COOL

PRIUS INVERTER COOLING

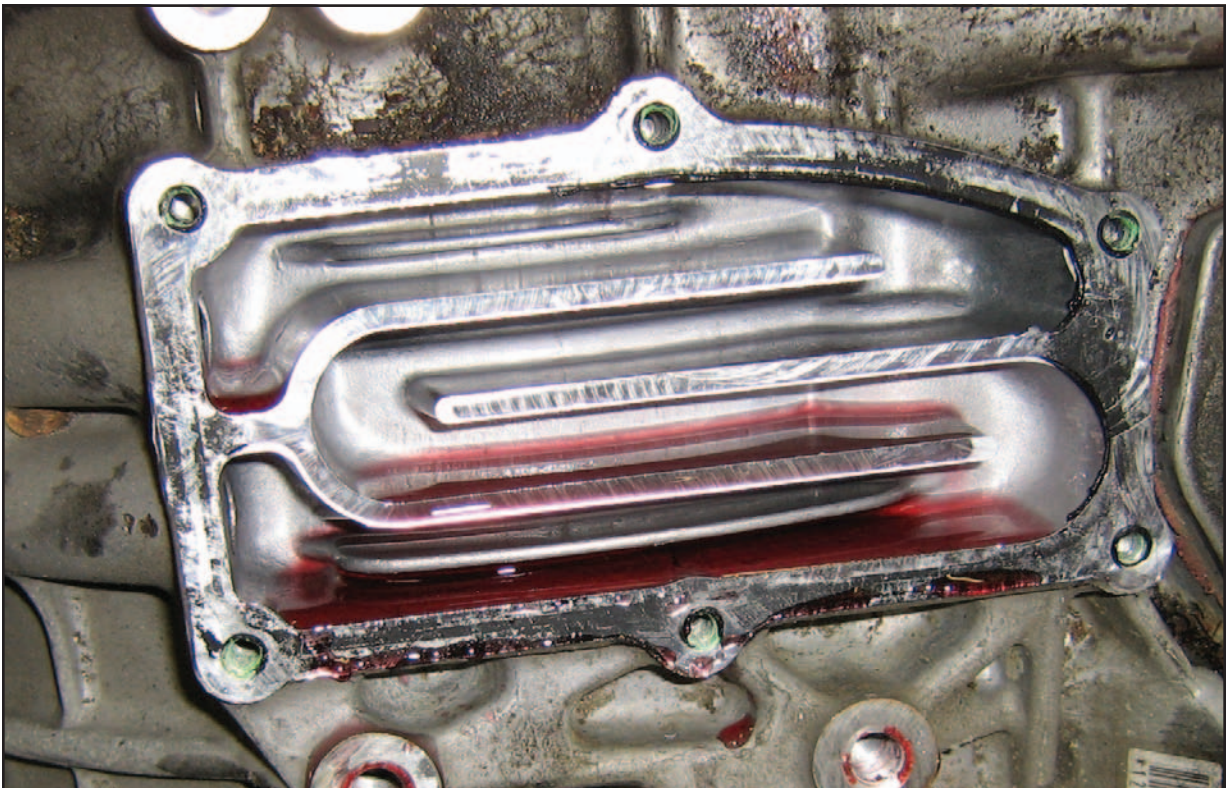
The MG2 heat sink is on the very top of the transaxle. It's hard to remove air pockets from this area without a vacuum fill tool.

■ The transaxle heat sink is near the top of the transaxle and the inlet/outlet pipes are near the center of the transaxle. The heat sink chamber can become air locked during service. A vacuum fill tool is the

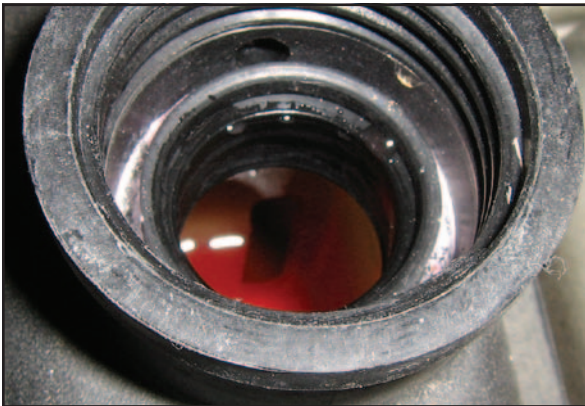
If the coolant is still or barely moving, there's a problem.

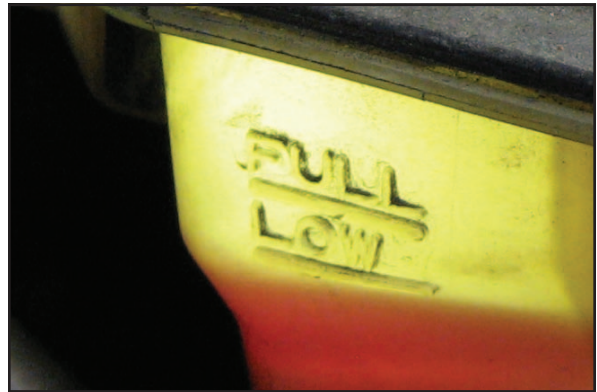
The inverter reservoir can become opaque as it ages. A flashlight is helpful when checking the level.

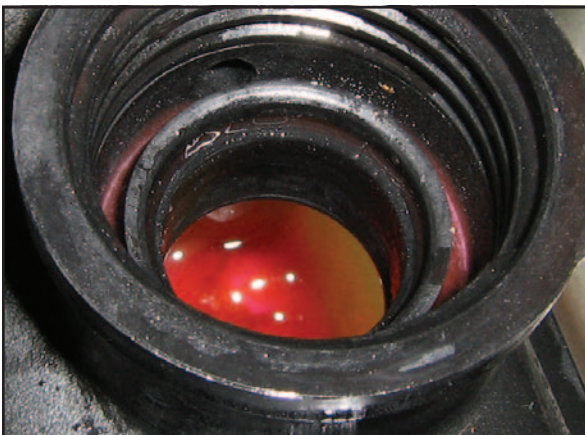
When the pump is working properly, you should see a fair amount of turbulence.

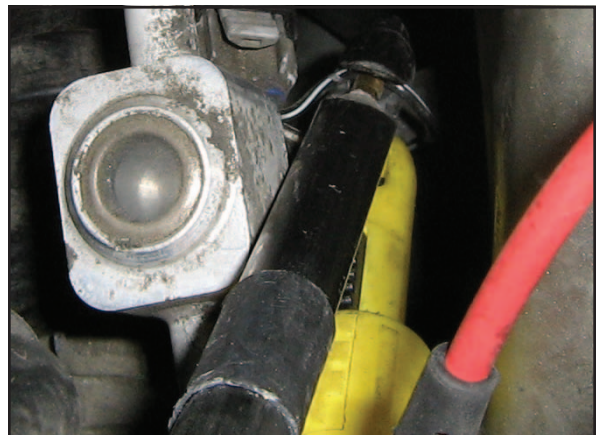
Use a seam splitter to slit the protective sheath, and then use piercing probes to check voltage.

placid pool of pink tranquility under the cap, check for voltage across the two-wire connector at the inverter pump with the power mode in READY or ON. No coolant flow + Battery voltage across the inverter pump = Bad inverter pump. Simple huh? Flat rate diagnostic guys rejoice!

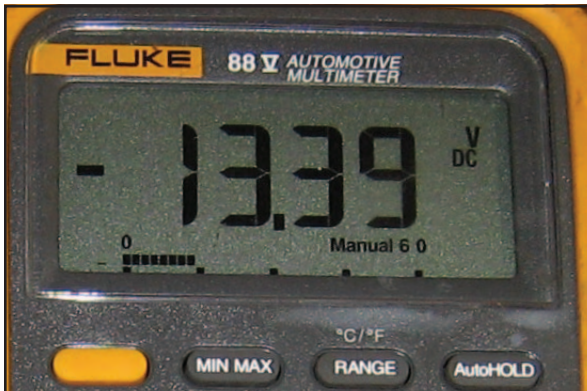
If the pump is powered, coolant should be flowing.

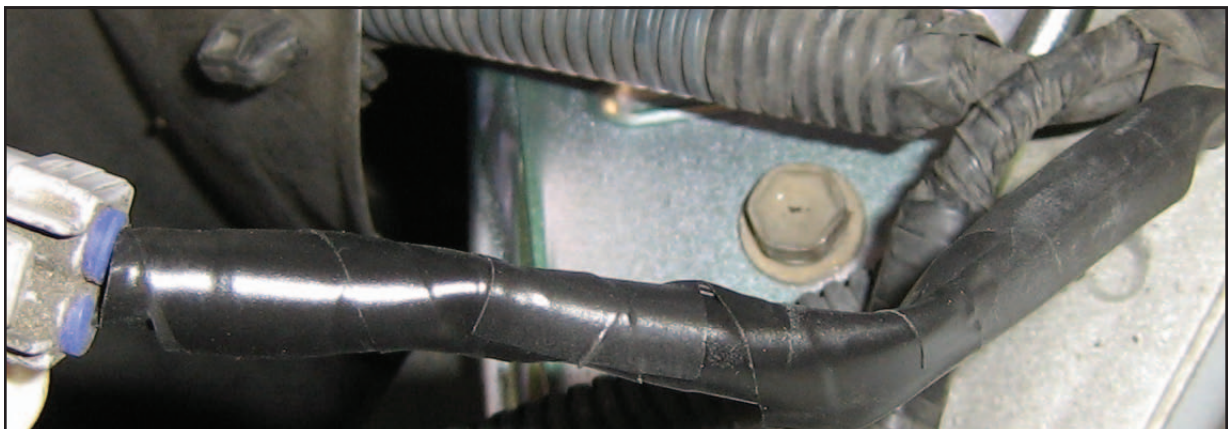
Piercing probes can save a lot of time and can often provide more reliable contact than back-probing, but always remember to repair any insulation holes and rewrap the harness.

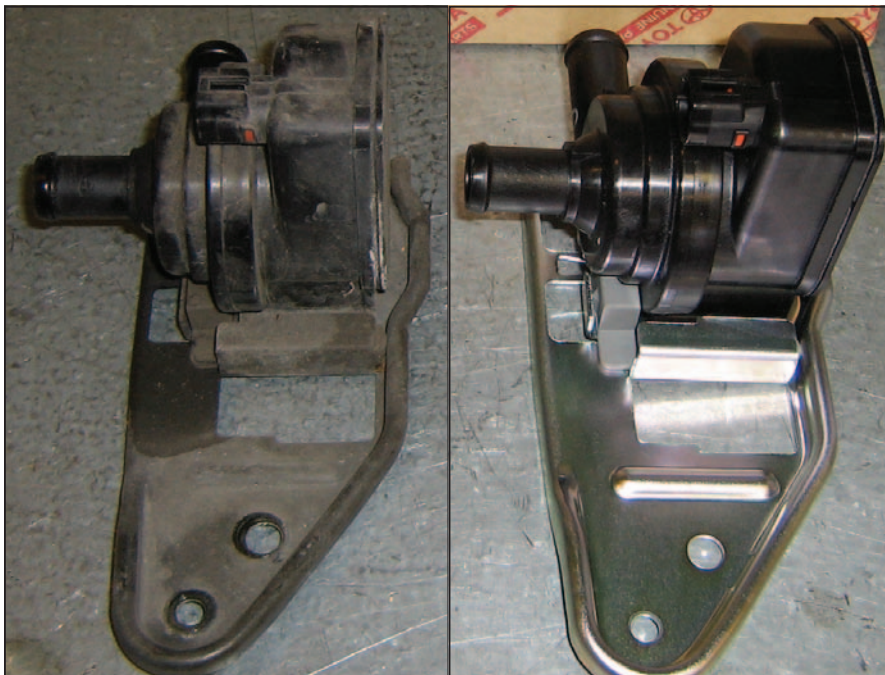
The redesigned Gen 1 inverter pump can be identified by the silver colored bracket.

- Gen 1 TSB EG023-07, which addresses the improved inverter water pump, also contains a "Plan B." If the inverter pump flow seems adequate, and the code set while ambient temperature was above 90 deg. F, Plan B is to replace the inverter with an updated unit. If the inverter is out of warranty (8 years/100K miles), this could be a pricey repair for your customer. If the inverter pump is original, it makes sense to do your best to confirm that the problem is not caused by an intermittent pump failure. In fact, replacing a seemingly good pump with an updated unit might be a gamble your customer is willing to take. A few

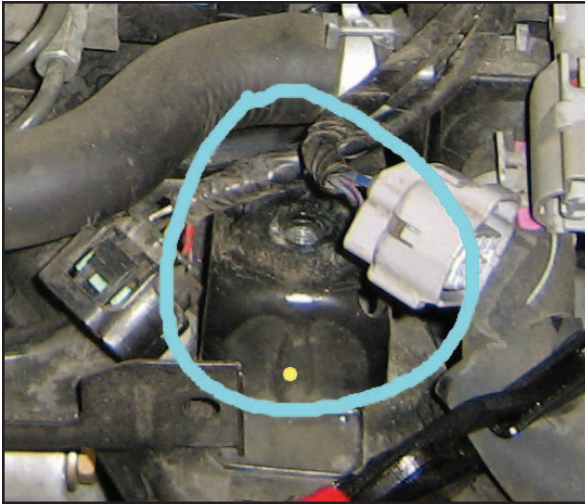
The rear inverter mounting point is circled.

While not directly related to the inverter cooling system, you may encounter the following during cooling system repair: When the inverter is hit, the rear mount bracket is often bent. If you remove the two front mounts and the inverter goes "SPROINGNGNG!" as it jumps up a few inches, this is probably the case. The ABS/VSC actuator is mounted to the rear mount bracket. If you've never done one, plan on it taking at least six hours. This job cannot be done without the Techstream since you'll need it for ABS bleeding and calibration.

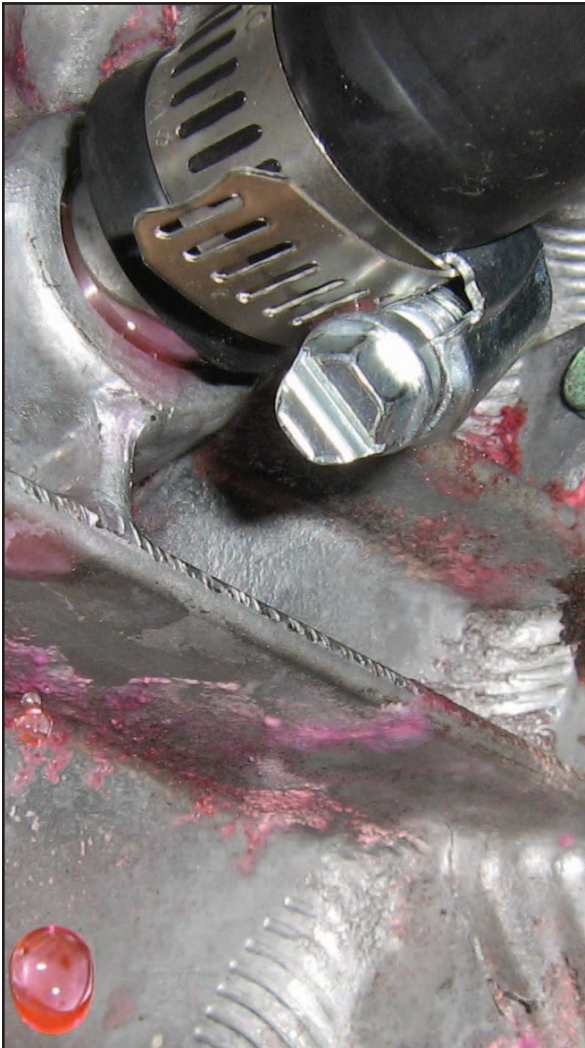
A new hose clamp won't fix this one.

■ Transaxles can be damaged at the coolant fittings. Sometimes body shops will figure the leak is coming from the hose, install a hose clamp and then assume it's fixed. I've seen post-collision-repair leaks from these fittings twice now. There's only one "right" fix: a new transaxle, an option that's bound to be unpopular with your customer or their insurance company.

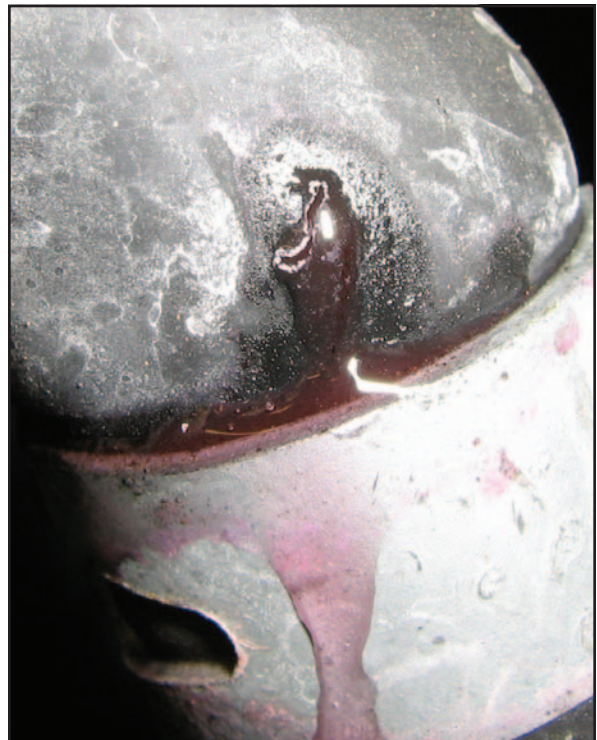
This hose was pinched.

■ Toyota hoses are of superior quality, so it's unusual to see a leaking hose even after eight years of service. However, hoses do get damaged during collisions or repairs. You may need a mirror and some patience to fully inspect all of the inverter system hoses.

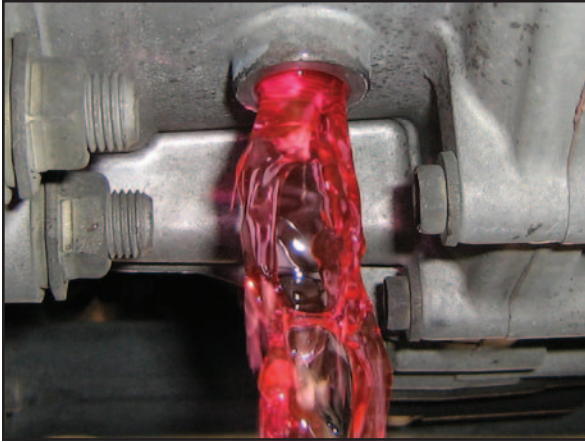
1. Remove the inverter reservoir cap, then remove the inverter drain plug in the transaxle.

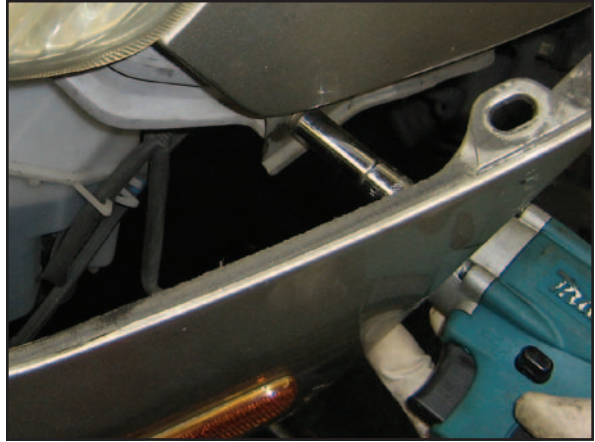
3. Here is the hidden headlight nut. The other two fasteners are on the top of the headlight housing in plain sight.

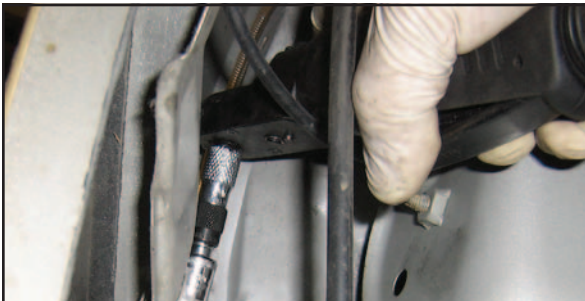
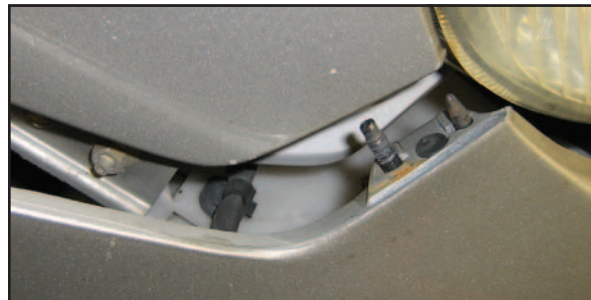
2. Remove the bumper cover. This is necessary because the bumper blocks access to one of the headlight bolts. Most of the bumper's fasteners are obvious, except for the two nuts hidden in the wheel well.

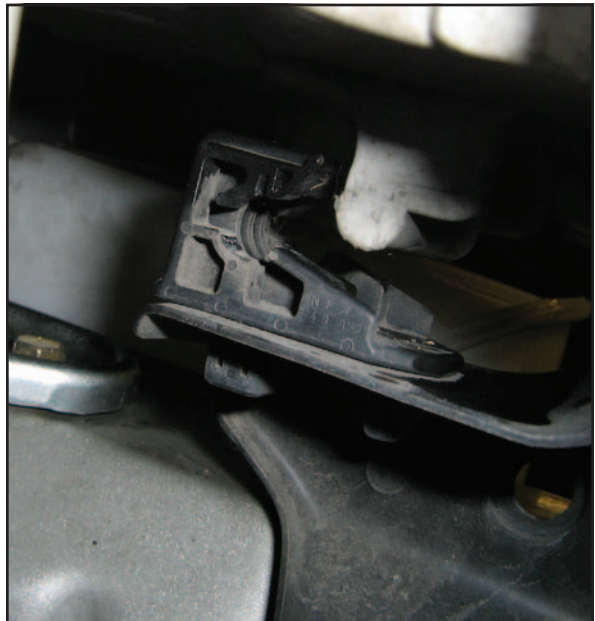
4. There is a retaining clip in the inner lower corner of the housing. Just pull the headlight housing towards you to release it.

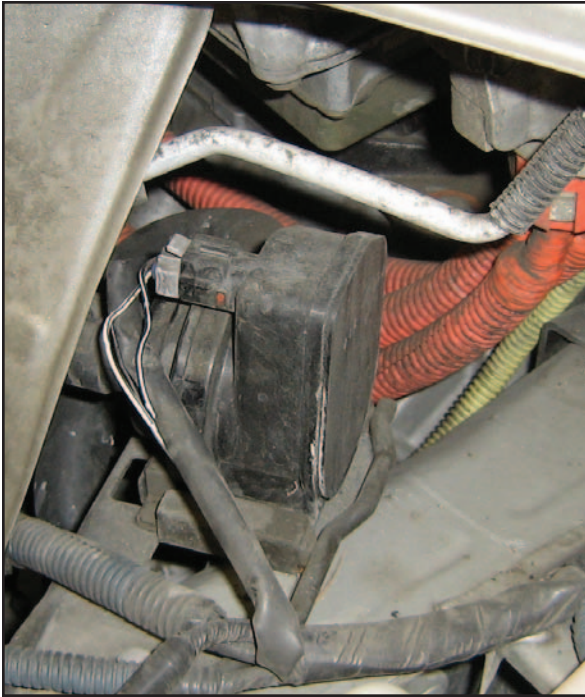
5. Once the headlight is out of the way, the pump is easy to access.

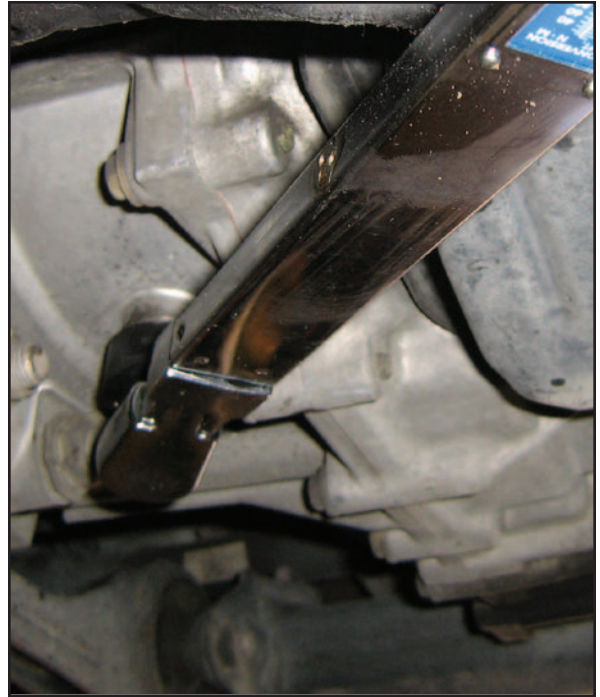
Install the inverter drain plug and torque it to 29 ft/lb.

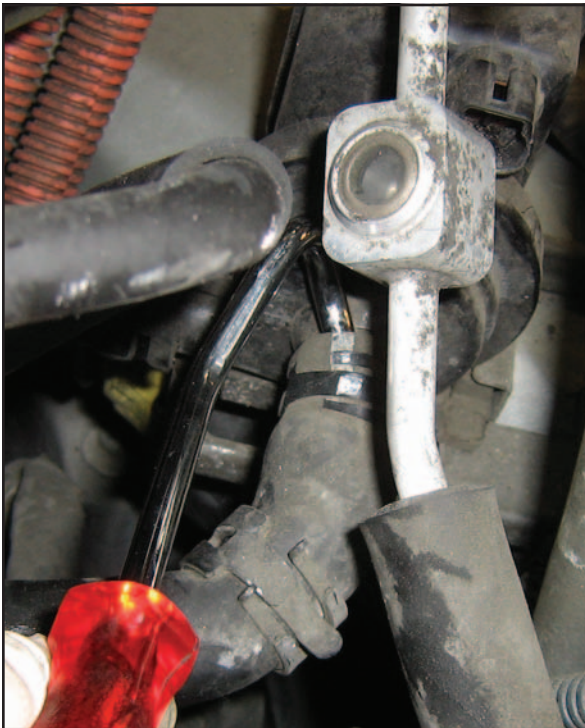
If you are planning to reuse the hoses, use a hose pick to separate the hoses from the inlet and outlet.

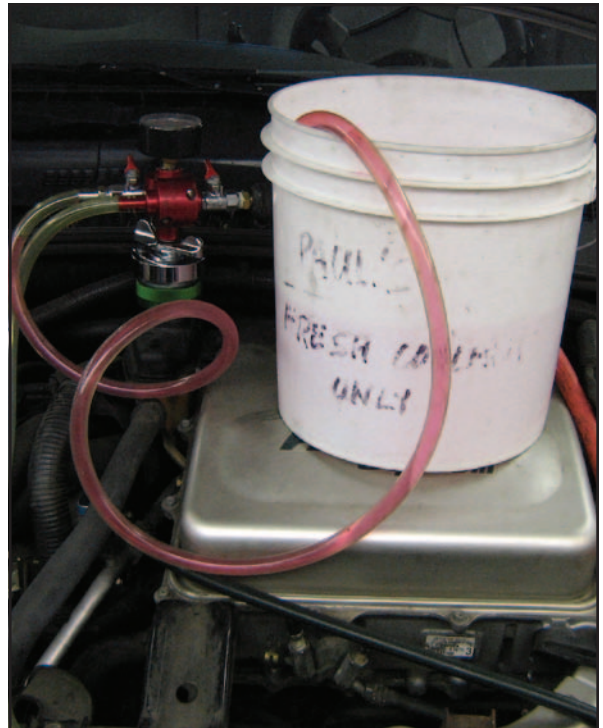
Use a vacuum fill tool to fill and bleed the system.
