# Volkswagen Certified Collision Repair Facility

*+ Fixing the Car and the Process*

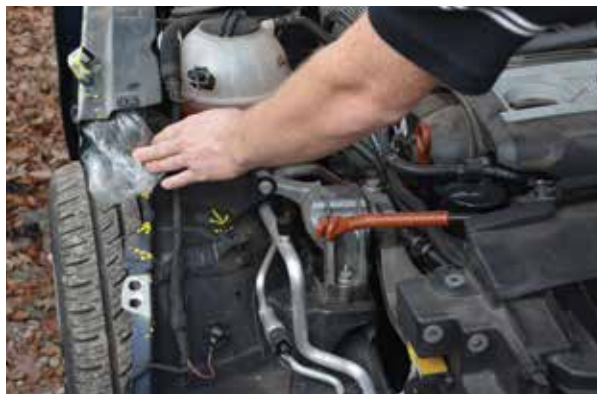
*Check your repair information for locations of sound-deadening insulation in the repair area, and replace it if missing or damaged.*

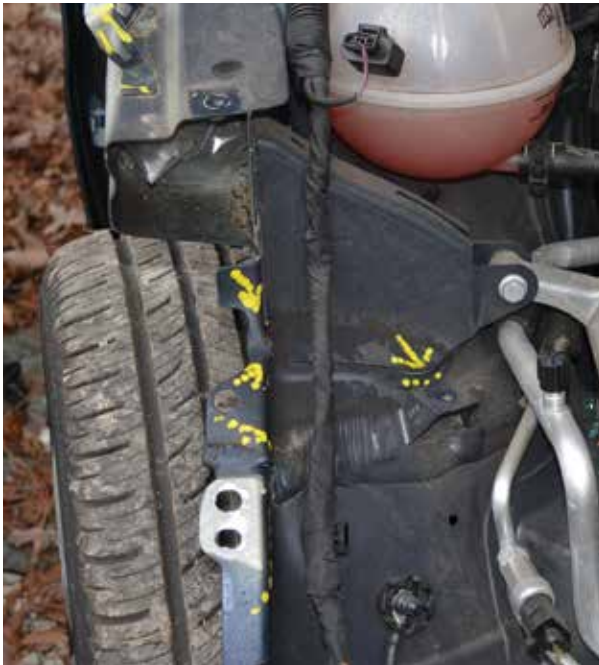
*Yellow arrows show where the front wheel apron is separated from the engine mount support that connects to the upper inner structure. If the dent is minor, the part may be straightened and welded. If the metal has a hard line, or kink instead of a slight depression, the apron must be replaced. If however, the metal has only a slight curvature, the damage may be light enough to allow straightening.*

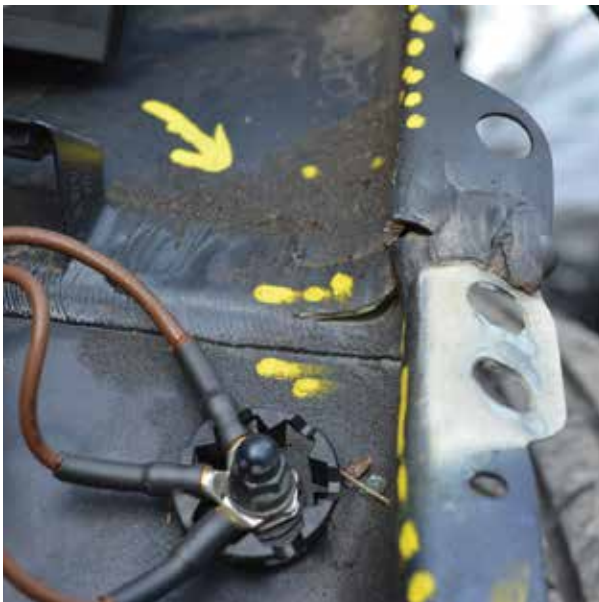
*This factory-applied seam sealer on the wheel apron provides corrosion protection. The metal has torn in several areas, but may be repaired. It will be reattached using adhesive bonding and riveting.*

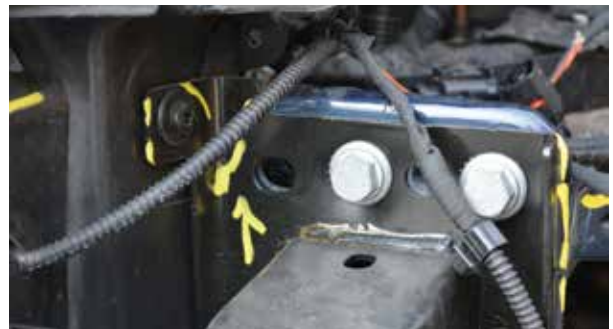
*Note the damaged and missing paint above the weld and the impressions in the metal where the bolts were originally torqued down. The black impact bar (bumper support) has been damaged in a front collision and must be replaced to meet safety requirements. If the impact also bent the rail enough to create a kink in the metal, that can cause work hardening and brittle conditions in the damaged area. If so, the rail cannot be straightened, and must be replaced.*

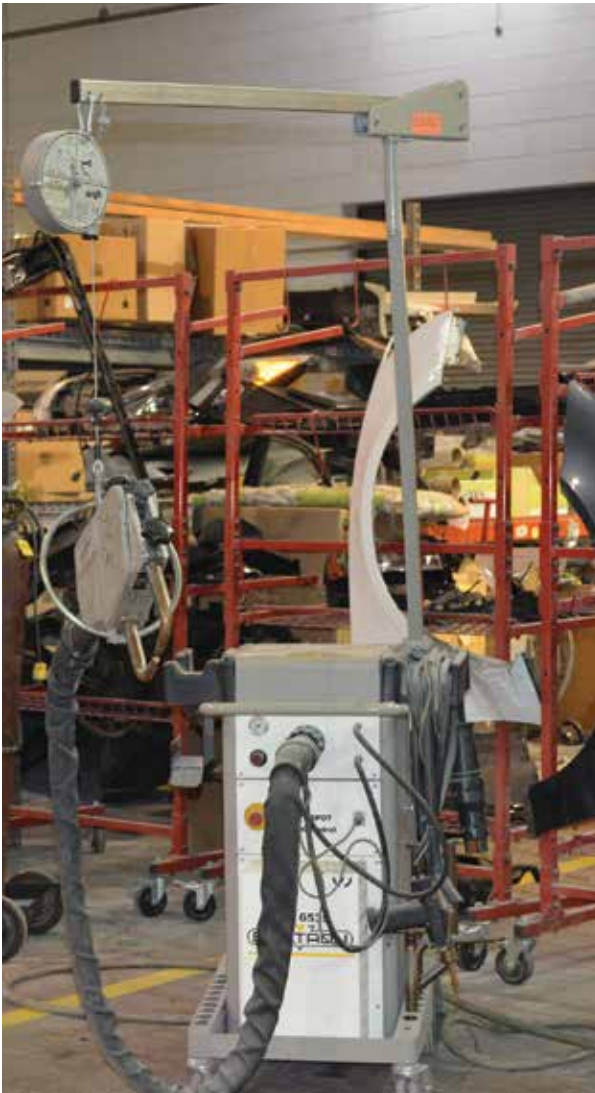
You'll need a squeeze-type-resistant-spot-welder (STRSW) such as the ElekTron® Spot Welder®, which is approved by VW. STRSW equipment can work using less heat than a MIG welder, making it flexible enough for use on a variety of metals, including ultra-high-strength steel (UHSS).

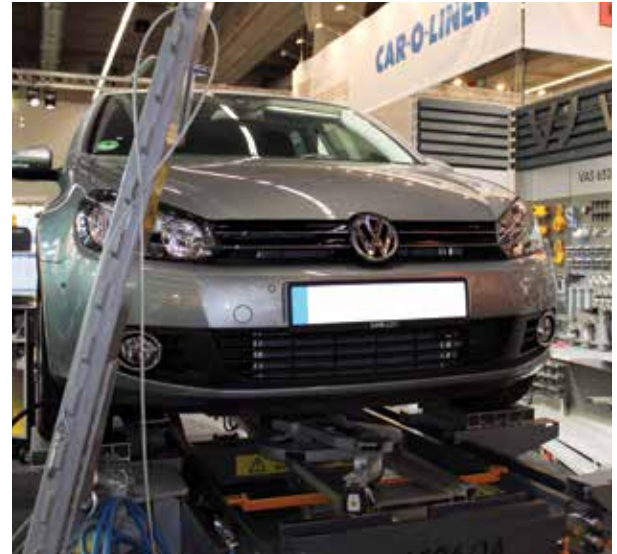
The Car-O-Liner® Quick 42 is a bench that offers the precision and durability required for collision repairs, and is approved by VW. It is compatible with specially designed fixtures in the VAS 6528 system that make it adaptable for both structural and cosmetic VW repair. Photo courtesy of Car-O-Liner®.

Celette® and Car-O-Liner® are the two frame benches approved in the CCRF program. Celette® manufactures a Volkswagen-dedicated bench, and Car-O-Liner® makes a universal bench that, with optional VW-specific fixtures and jigs, can pinpoint a frame rail as well as a factory robot.

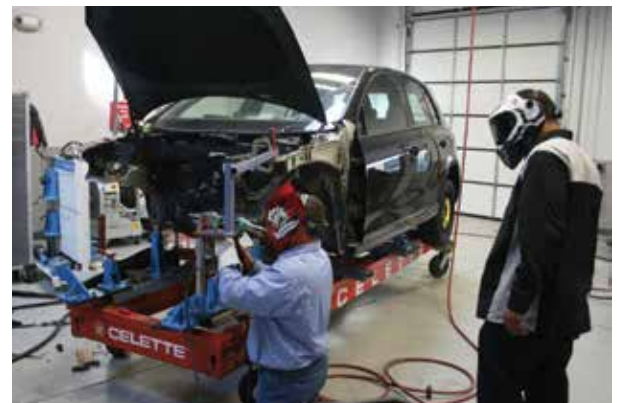
The Celette® bench allows quick attachment and adjustment of its straightening brackets, gauge system, cross members, towers and wedges. It positions the fixtures at the proper measurement points for precise repair on any VW model. Photo courtesy of Warren Barbee, Volkswagen Collision Training.
