BMW Diesel Overview

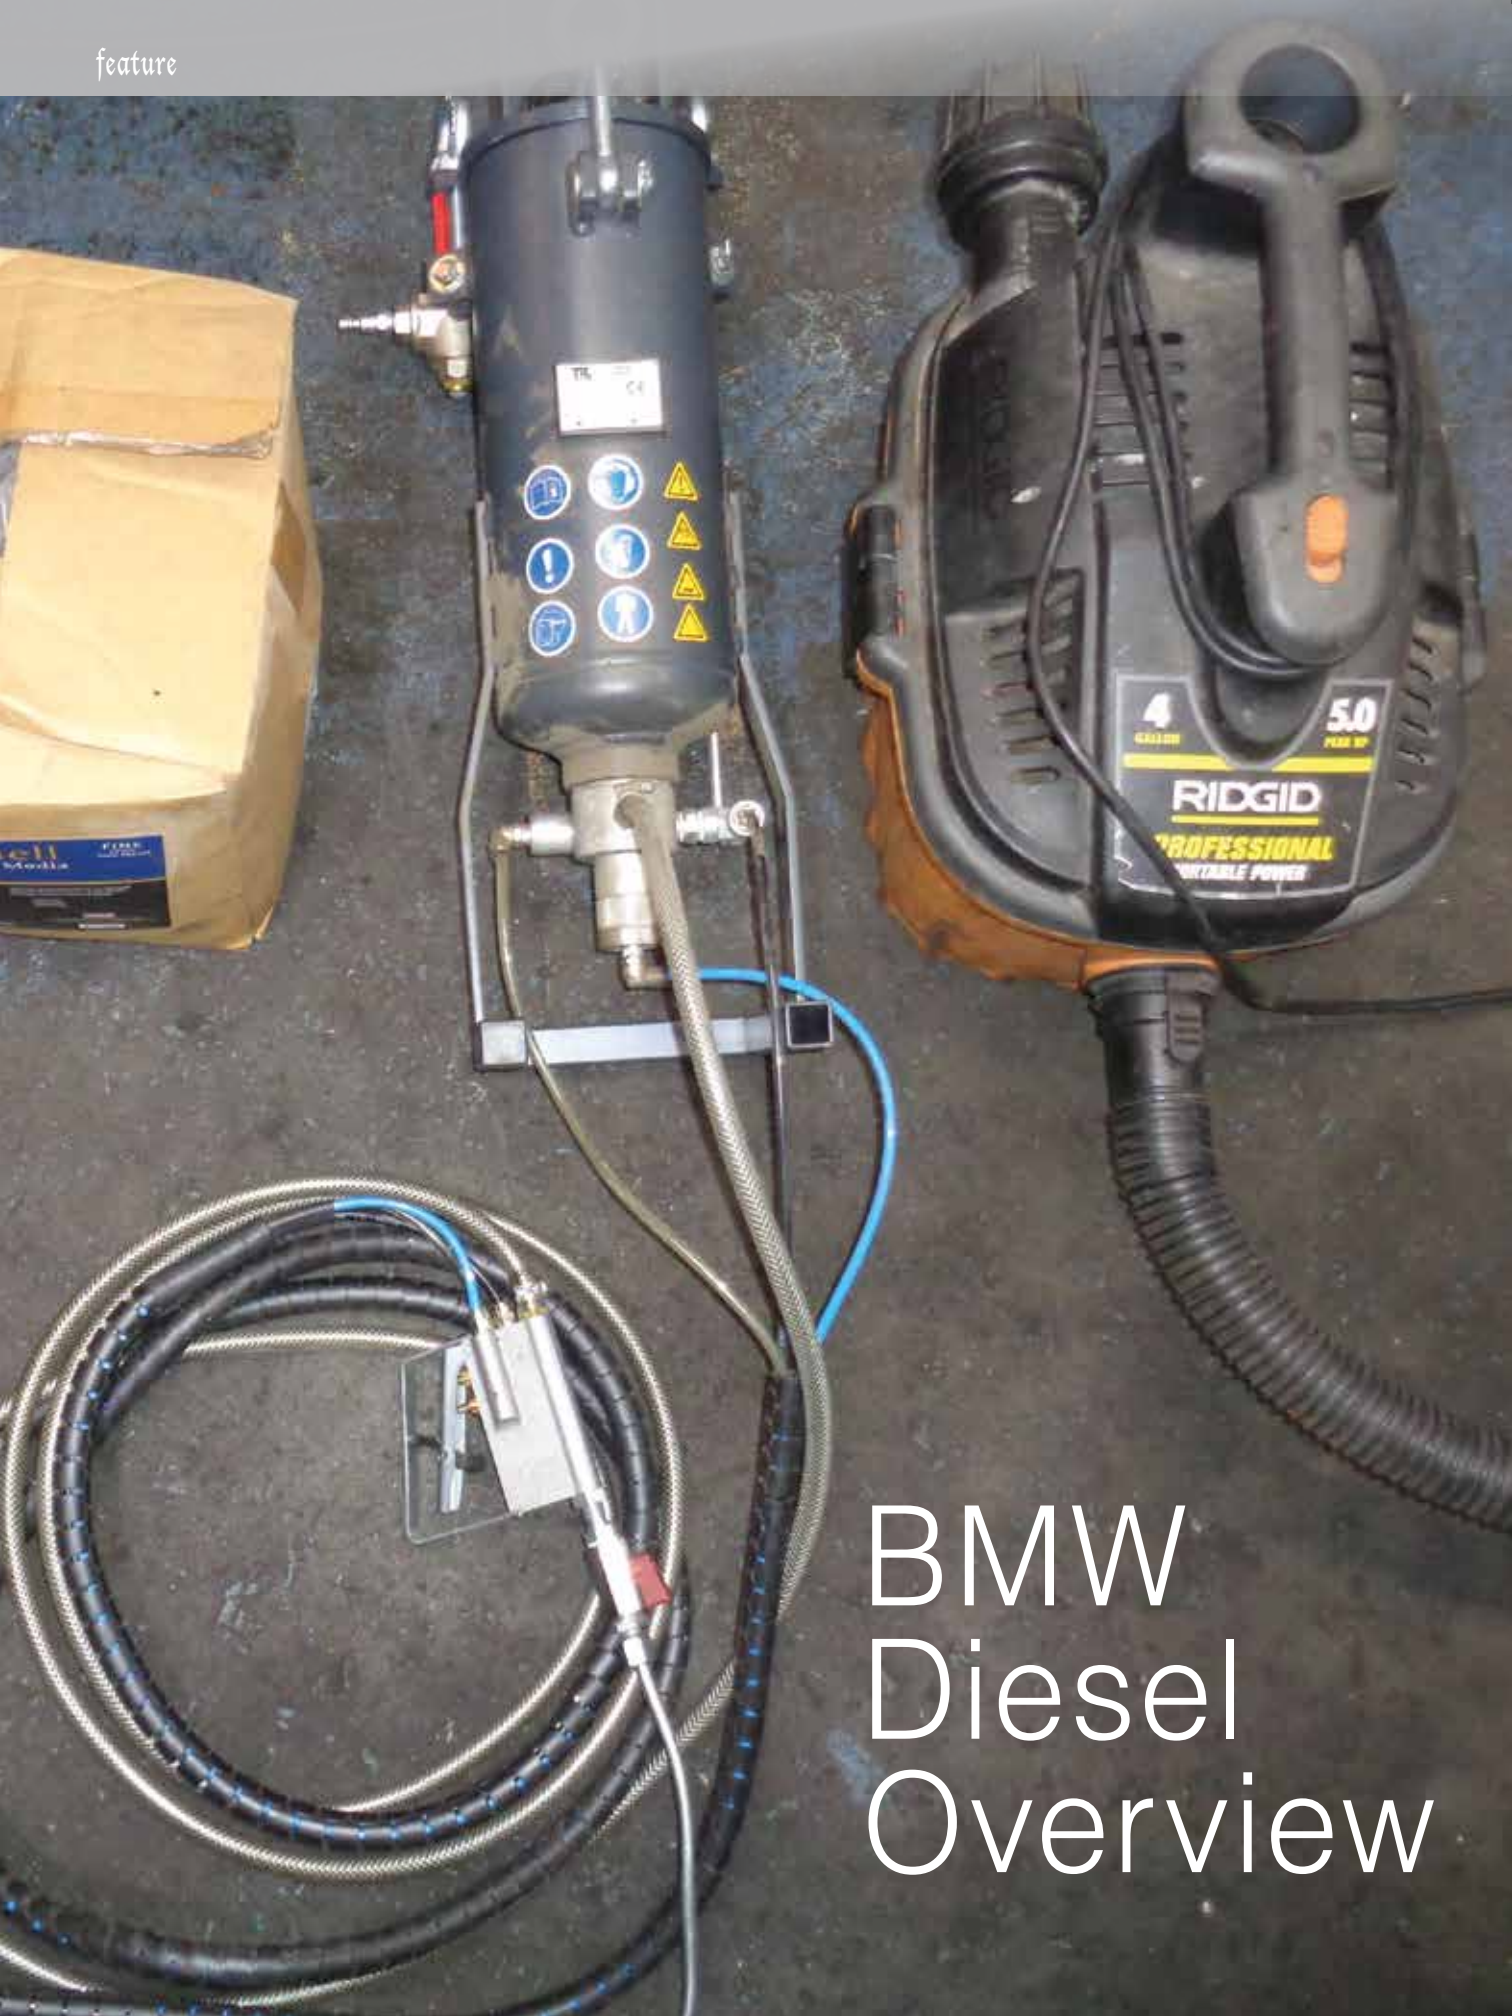
Opposite Page: A pressure controlled media blaster has anti-clogging purge action! It's best to use medium or fine walnut shells for de-carbon services.

A side note: In higher-mileage vehicles, the glow plugs may become stuck in the cylinders from carbon buildup and corrosion, making them all but impossible to remove without stripping out the threads in the cylinder head. By pre-treating with a penetrating oil spray and getting the vehicle to full operating temperature before attempting removal, the risk of engine damage can be lowered. Do not heat

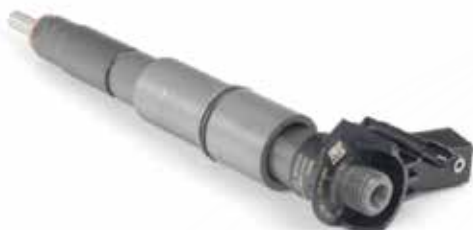
The classification values are visible on the plastic base plate on the injector. Note the fragile line fittings, be careful not to damage them.

If diagnosing a faulty fuel injector, it's possible to move the injector to a different cylinder to see if the rough running will follow the injector. Each injector has a specific classification value that determines flow characteristics. These values must be entered for each fuel injector on the corresponding cylinder. Failure to store proper injector classification values can cause issues in itself and should not be overlooked when swapping or diagnosing injectors. This is a critical step with BMW injectors and can only be done properly with BMW ISTA software or a comparable factory-level tool.

BMW injectors incorporate a fuel injector return line. This is where unused fuel is returned to the fuel system. The return line setup on the fuel injector is quite small and prone to damage if not properly secured. If the return line feed is damaged at the fuel injector, the entire injector must be replaced. These are not cheap! Be careful.

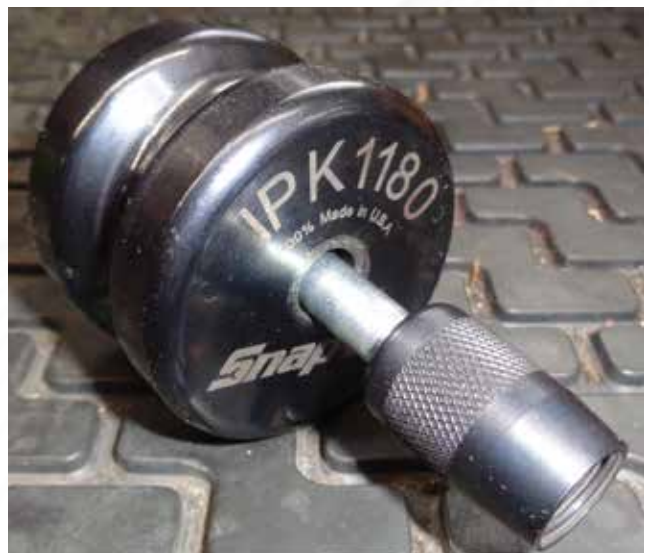
The mini slide hammer is a must for both gas and diesel injectors.

When replacing fuel injectors, care must be taken not to damage them. Particularly on diesels, the injector can become quite stuck in the cylinder head. BMW offers a small slide hammer tool that threads onto the fuel injector to aid in removal. This is a necessity! If the fuel injector is equipped with a Teflon seal ring, do not use any chemicals or lubricants on the seal. It's best to keep the seal covered until it's ready to be installed. Always replace the copper crush washer as well, if so equipped.

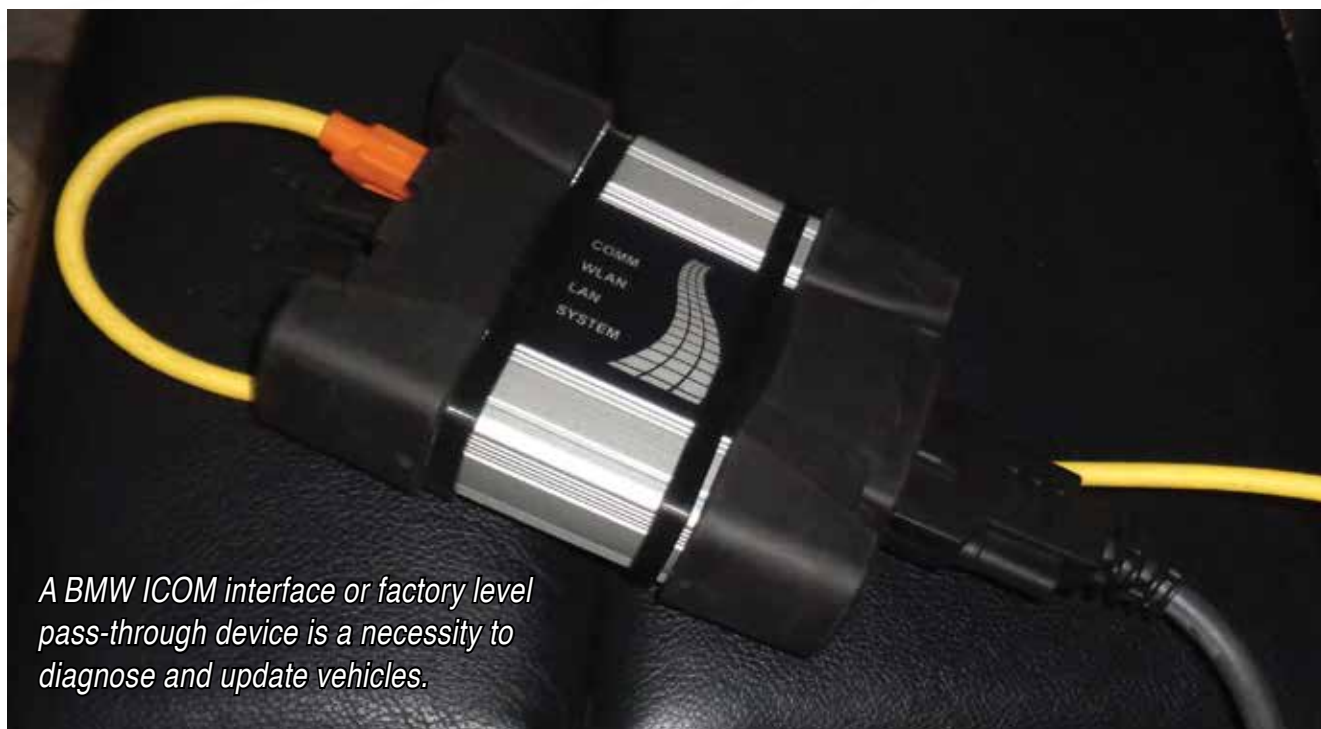
A BMW ICOM interface or factory level pass-through device is a necessity to diagnose and update vehicles.

The fuel injection system is controlled by the DDE. The first step in any diagnosis is to run a full scan of the vehicle as well as verify current I-level or Integration level of the vehicle. On BMW vehicles, the I-level is used to verify update status of all connected vehicle control units. Many issues and problems can be eliminated by updating vehicle systems to a current I-level. Most SIBs (Service Information Bulletins) list the I-level for the corresponding bulletin, so it can be quickly determined if the vehicle requires updates.

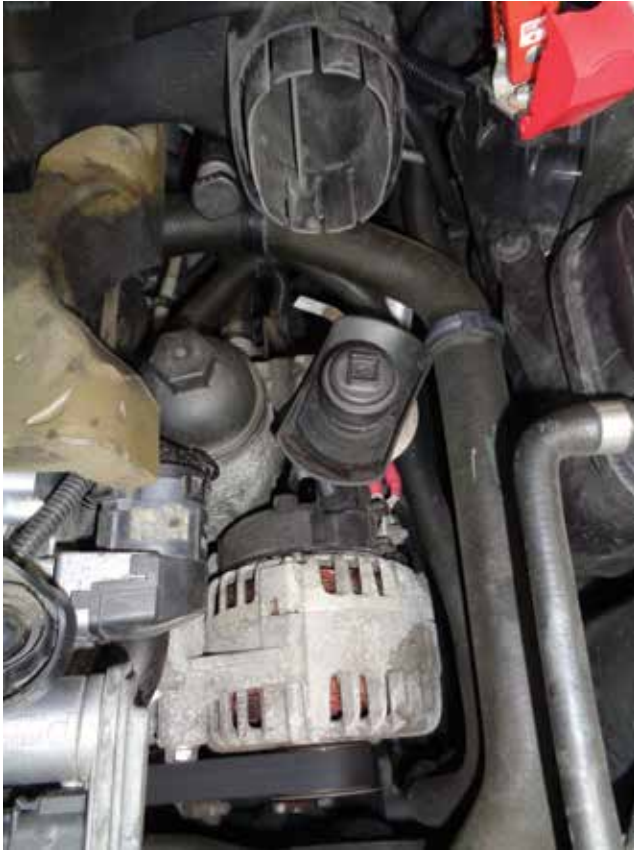
There are two fill locations for DEF on the X5. The larger DEF tank fill is directly next to the oil filter housing. The smaller active tank fill is located on the passenger front of the engine bay.

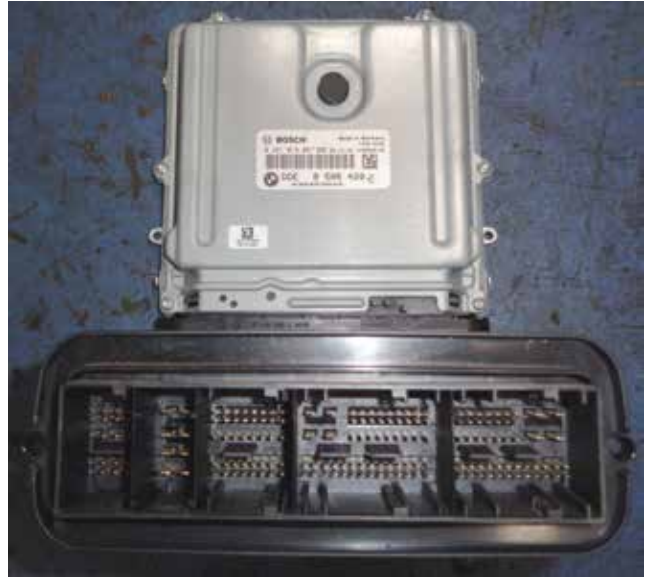
A failed DDE is the last place you might suspect an issue.

In addition to requiring updates, DDE can have problems of its own. The DDE control unit houses individual drivers for each fuel injector. In certain cases, the drivers can fail inside the control unit. The problem if the driver fails is that the DDE will not recognize the internal failure.

Most commonly a failed injector driver will manifest as a rough running in one or more cylinders. Often, smooth running faults are stored and the vehicle will point blame toward the fuel injectors. Even after swapping fuel injectors and performing a de-carbon service, these faults can return with a bad DDE. The only way to be certain of a bad DDE is to monitor the fuel injector signal with an oscilloscope. Only then can you verify proper grounding of the fuel injector circuit.

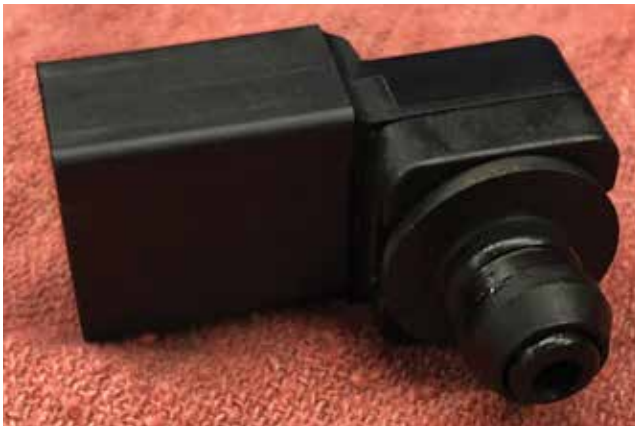
Manifold pressure sensors have a high failure rate due to fouling from carbon buildup.

The M57 and N57 engines both have charge air pressure sensors on the intake manifold. These are susceptible to failure because of blockage from

carbon buildup as well... lots and lots of carbon. These pressure sensors generally cannot be cleaned or repaired and must be replaced if found to be faulty.

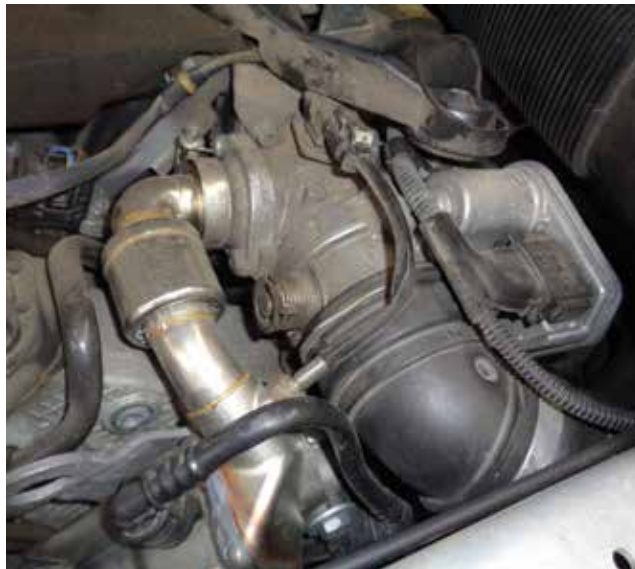
The EGR valve is mounted between the intake manifold and throttle unit. Also note the small flex pipe on the EGR. These do fail occasionally, leaking exhaust gases.

Don't forget to inspect and clean the EGR (Exhaust Gas Recirculation) valve if necessary during de-carbon service. On the M57 engine, this is located

forward of the throttle unit. Due to air flow around the valve, carbon tends to build up around the valve sealing surface, eventually disrupting full airflow and in extreme cases restricts the EGR valve from proper movement.

The EGR valve is necessary to help lower nitrogen oxide (NOx) emissions. EGR valves operate by recirculating a small amount of the vehicle's exhaust gases back into the intake tract. BMW diesels come equipped with EGR coolers, which lower the exhaust gas temperatures on their path to the intake manifold. By using exhaust gases, it's possible to lower the oxygen content of the intake charge. The goal of this is to lower peak combustion temperatures, which can greatly reduce NOx emissions. This is particularly important in diesel engines, which already have extremely high combustion temperatures.

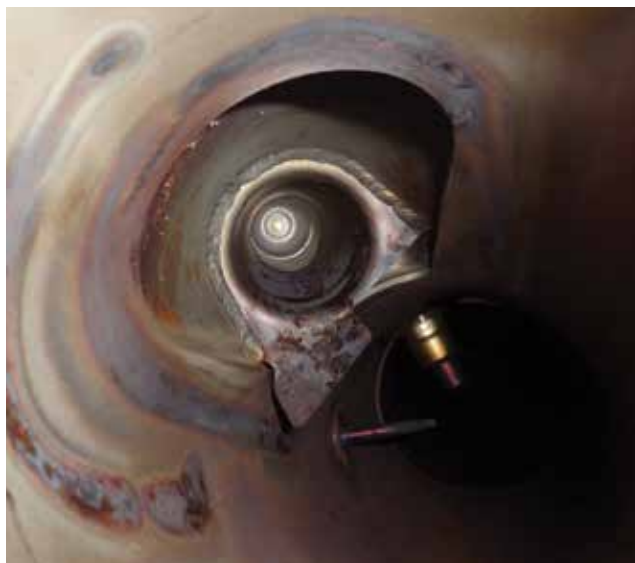
This view of the inside of the exhaust system shows just how clean BMW diesels really are! The DEF injector can be seen top left.

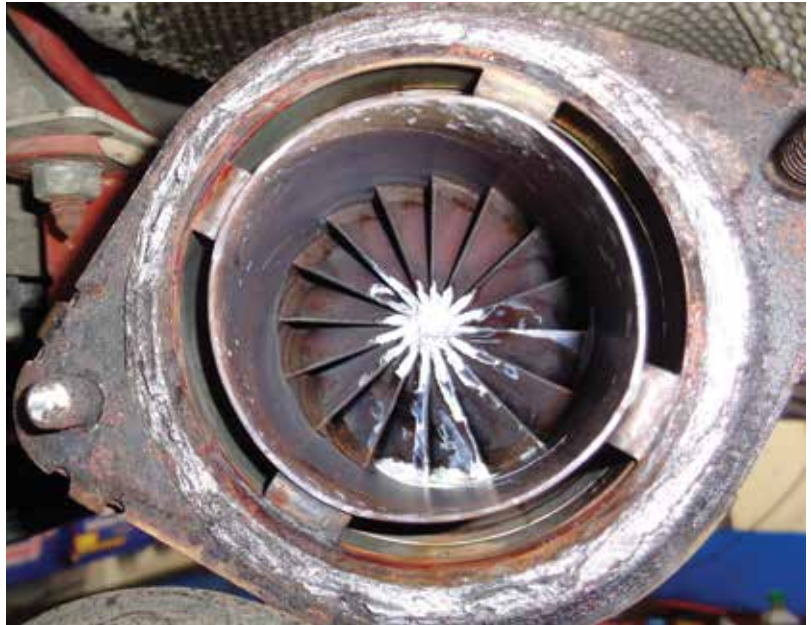
This is the "mixer" which aids in vaporizing injected DEF fluid.

BMW uses a urea dosing valve mounted at the front of the SCR converter to inject DEF into the exhaust stream. This is followed by a “mixer” gasket to aid in DEF vaporization.

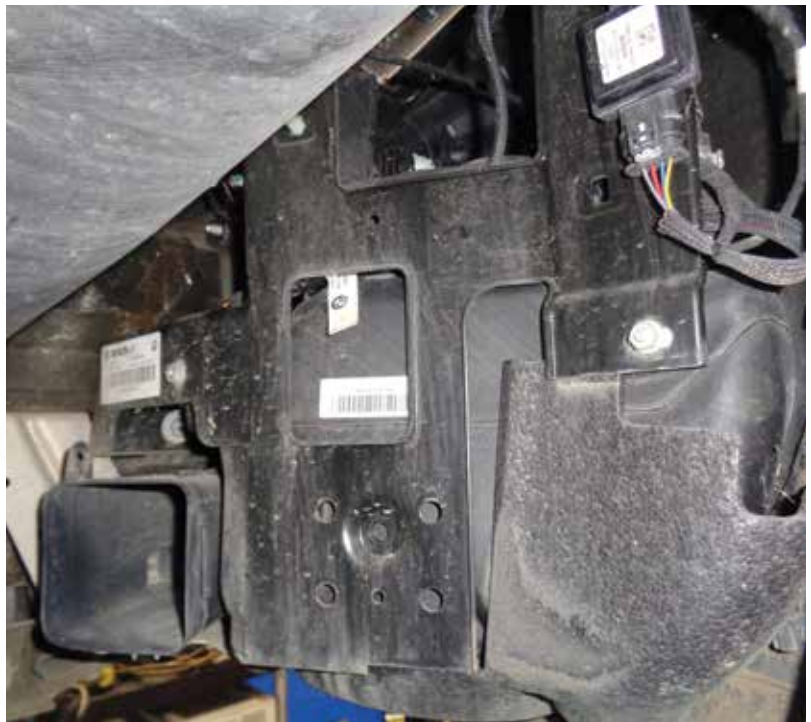
This is the active DEF tank on an E70 chassis diesel. Located in the passenger front wheel well, access is very limited without removal.

The DEF tanks have become a common failure item on many BMW diesels. These tanks are equipped with multiple sensors to monitor and condition the DEF for proper delivery. Heater circuit failures and temperature sensor failures are extremely common for BMW DEF tanks. At this time, it's necessary to replace the entire tank assembly to replace the faulty sensors. No serviceable parts are available separately from BMW for this equipment.
