# ELECTRONIC THROTTLE MODULE (ETM)

Unlike the old butterfly mechanical throttle bodies, when all you needed was a screwdriver to adjust the idle, electronically controlled throttle modules started in 1999 for Volvo models S70, V70 AND XC70. Let's go over failure symptoms, how to clean, and how to replace an Electronic Throttle Module (ETM) in a Volvo.

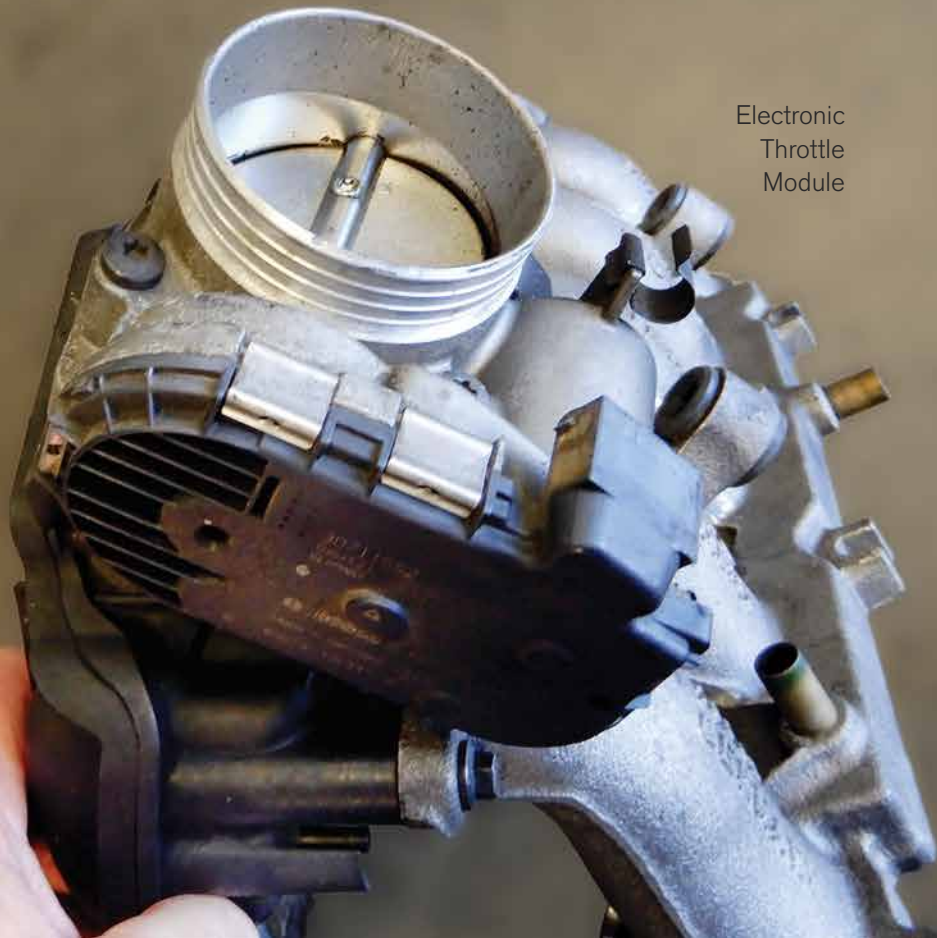
Electronic  
Throttle  
Module

Clean the throttle module with cleaning agent Volvo Genuine Part number 1161826 and a small brush. Make sure to clean all surfaces, open the butterfly and clean the edges. Carefully clean the complete area and wipe clean. Do not use compressed air when cleaning.

Install the throttle module with new gasket Volvo Genuine Part number 31430474 and secure the throttle module to the intake manifold. Connect the throttle module electrical connector and route the harness back into place. Secure the starter bracket. Install the plastic pipe at the throttle module and at the intercooler and tighten both clamps. Connect the electrical connectors at the air and MAP sensors.

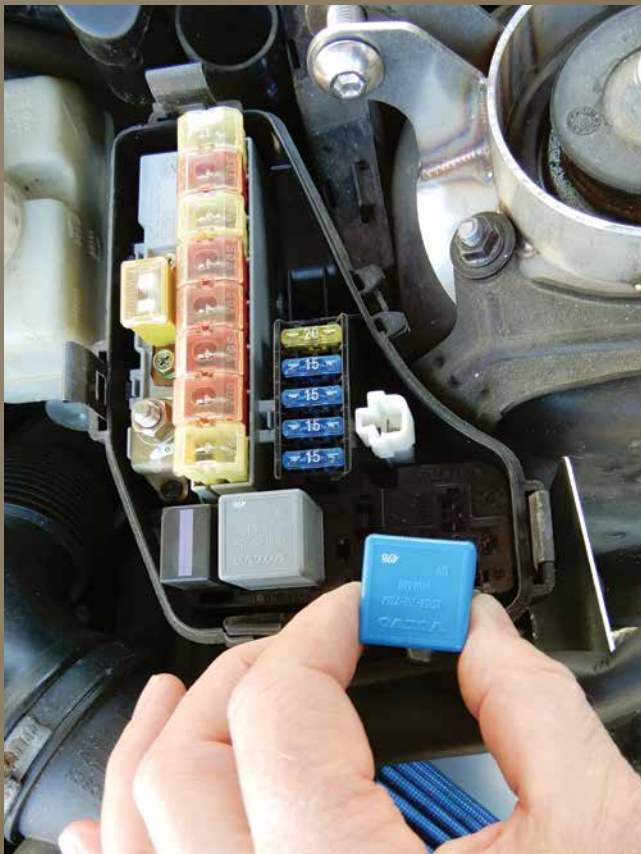
Fuse box main relay and B+ terminal

There are a few common areas that can cause significant current loss: the engine management relay, the ETM relay (only on 1999), the B+ terminal, or possibly a corroded ETM power supply.

Check the fuse at the fuse box at the left strut tower; check fuse #2 and replace if necessary. If this fuse is good check the engine management relay. 1999 Volvo vehicles had an ETM relay also. Replace both relays and check the vehicle. If the system continues to have problems there might be a problem with terminal B power supply. If the terminal looks to be corroded or burnt it will need to be replaced.

To replace this harness, use Volvo Genuine Part number 8628771. Separate the fuse box and remove the 13 mm nut that holds the cable to the fuse box. Remove the air filter box. This harness runs from the battery to the fuse box. Remove the plastic liner around the wire harness.

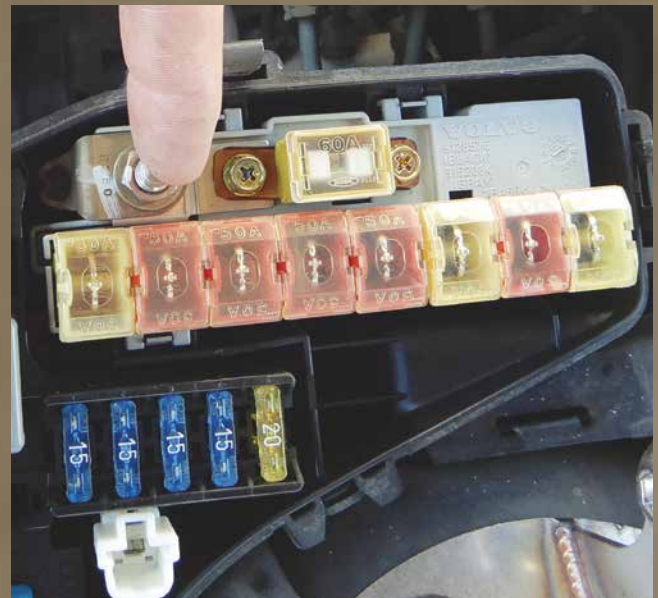
Harness connected at fuse box 13 mm nut

Install the new harness, connect it at the battery and at the fuse box, and secure the harness. Snap the fuse box back together and install the air filter housing. Start the vehicle and make sure all codes are gone from the system. ●
